**OLD ARCATA ROAD IMPROVEMENTS PROJECT
HUMBOLDT COUNTY**

HISTORIC RESOURCES REPORT

February 2020

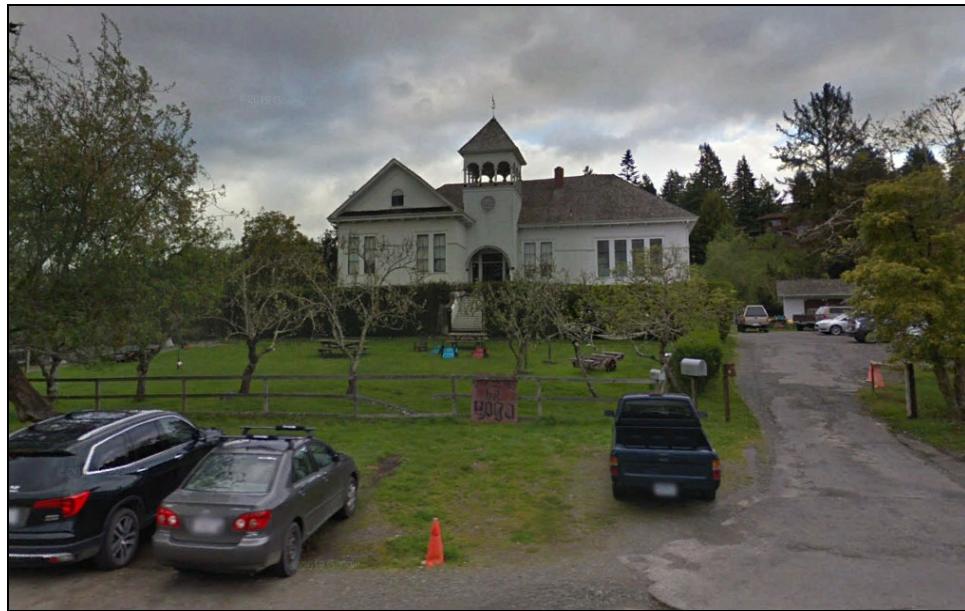
Photograph 1: 2212 Jacoby Creek Road (Google Earth, Imagery Date 4/2019), facing north.

The Old Jacoby Creek School / Bayside School was listed in the NRHP in 1985 (NPS-85000353-0000). Located at 2212 Jacoby Creek Road (**Photograph 1**), it was built in 1903 by W.G. Mohn.⁶ Historian Susie Van Kirk prepared the nomination and the school was determined eligible under Criteria A and C at the local level for its associations with the development of the Bayside area, as well as for its unique transitional architecture in Humboldt County. The period of significance is 1903-1957, the latter date being the opening of a new school building. The property boundary is defined by its historic parcel. Van Kirk notes that changes to the rear wall on the north corner took place in the 1960s and that the owners had intended to replace the front steps, which were missing at that time. Desktop review confirms that those steps have been added to the building since its listing.

The Old Jacoby Creek School is a large wood structure with approximately 4,900 square feet of floor space included on the main floor and in the basement. It sits...on an acre of land screened by pines and alders.

The front facade is "L" shaped with a pedimented gable at right angles to a hipped-roof section. Nestled in the "L" is a square belltower with a pyramidal roof. It is open at the top by twelve decorated arches. The pediment has wide eaves, a plain frieze, and a small window with ventilation slats above. Beneath the eaves of the pediment is a line of false rafter ends which is repeated around the entire building. The main room below the pediment is lighted on the front by two pairs of long, narrow windows of six panes each. The basement has a central door flanked by single, four-pane windows. A door, leading to interior steps to the main floor, has been added at the base of the belltower on the southeast side.

The double front doors are wood with large glass panes. Recessed behind an arched entrance below the belltower, the doors are bordered by a transom and sidelights. The front steps were removed some time ago, but will be replaced as part of the owners' rehabilitation plans. A door has been added off the porch into the main room at the west corner of the building.

The building is covered with three different sidings. The belltower, pediment and upper portion of the main building have fishscale shingles. A raised moulding separates the shingles from an overlapping board siding which extends to the water table. The basement siding is cove-rustic shiplap.⁸

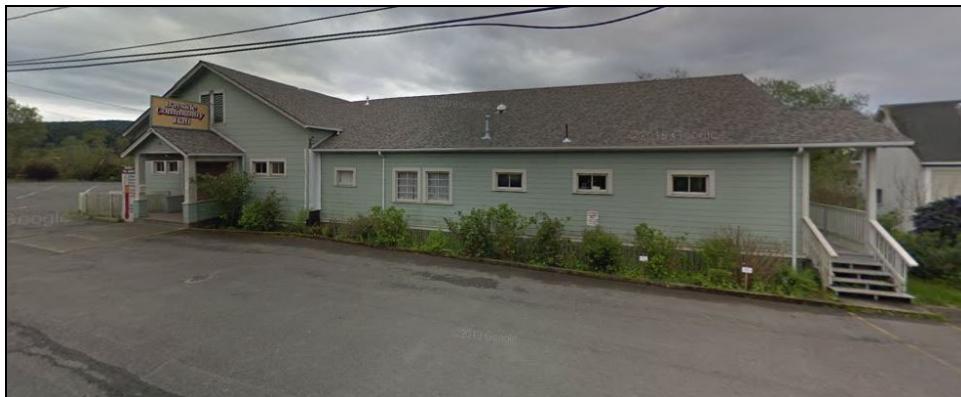
Photograph 2: 2297 Jacoby Creek Road (Google Earth, Imagery Date 4/2019), facing south.

The Bayside Community Hall (OHP #131410, Cal. Reg #12-0016) at 2297 Jacoby Creek Road was formerly known as the Bayside Grange (**Photograph 2**). The Office of Historic Preservation (OHP) listed the building on the CRHR in 2002 as the Bayside Grange Hall with a construction date of 1940.¹⁰ While it is known that the Community Hall / Grange Hall is listed in the CRHR, no other documentation for this property was found during research for this report or included in the HPSR.¹¹

JRP assessed the character-defining features of this property during the desktop review. The building, designed in the Minimal Traditional style, sits on a raised L-shape foundation with vertical wood siding on an angled grade. The rest of the building has horizontal wood siding. The cross-gable roof has both wide and narrow eaves and is covered in composite shingles. Each gable has a louvered vent. Underneath a front gable, a composite shingle gable porch with square half-posts serves as the north entry. It is framed by double horizontal sliding windows. On the west side, a gable projection with exposed rafters is supported by square posts and

shelters a side porch; it is accessed by wooden stairs. Single horizontal sliding windows and two over four fixed windows are located throughout the building. The one-acre property on which this building sits has some open space and there are trees at the southeastern corner, but the building is bounded on the south and east sides by paved parking lot, including the area immediately adjacent to Jacoby Creek Road. While the building's setback from the roadway can be considered character defining, the paved parking areas are not.

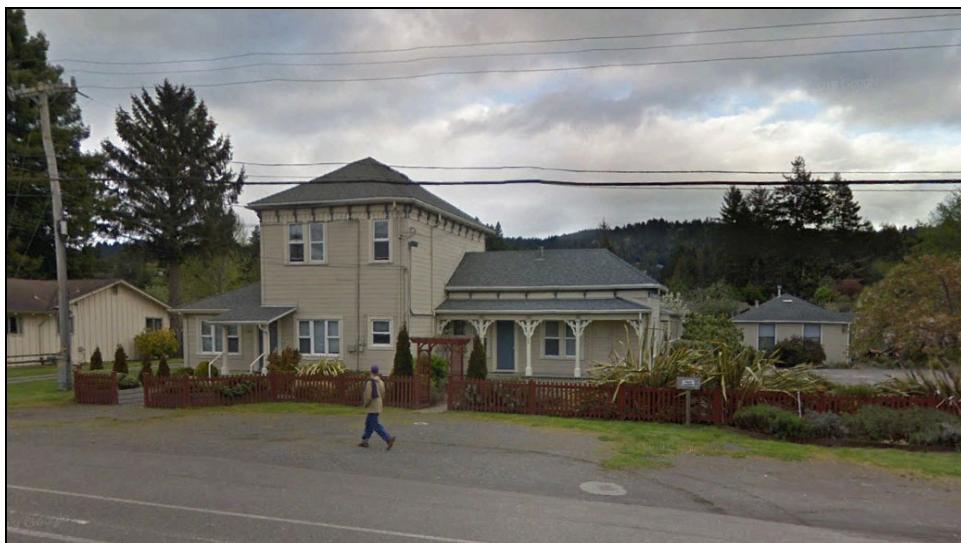
Photograph 3: 1788 Old Arcata Road (Google Earth, Imagery Date 4/2019), facing north.

The Charles Monahan-Dexter House and former Bayside Post Office (P-12-003658, Hedlund P-04) was built at 1788 Old Arcata Road circa 1887 (**Photograph 3**).

The main section is a two-story, 'four-over-four' room floor plan, with a hipped roof and brick chimney. The recessed one-story wing also has a hipped roof and brick chimney, with a hipped roof porch supported by four decorated posts extending forward over the entire front section. In the main section, the entrance is off center and covered by a narrow, slope roof portico supported on two posts on a raised stairway leading to the door. Another one story structure has been added to the other side of the main two-story section to serve as the post office. The exterior siding is shiplap with end boards. The trim at the eaves is ogee boxed cornice with frieze. The frieze on the two story section is decorated with dentils and bracket. All windows have plain molding; most are in pairs and are two-sash, double-hung, with vertical mullion dividing the sashes, which have two panes each.¹²

The property's frontage along Old Arcata Road includes a driveway entry south of the house, a narrow fenced front yard, and an unpaved parking area adjacent to the road. The front yard has some landscape features that appear to be of recent vintage.

The character-defining features of this property are understood to be the design of the house and its general set back from the roadway, which is approximately 35 feet. It does not appear, however, that the front parking area or landscaped front yard contribute to the historic character of this property.

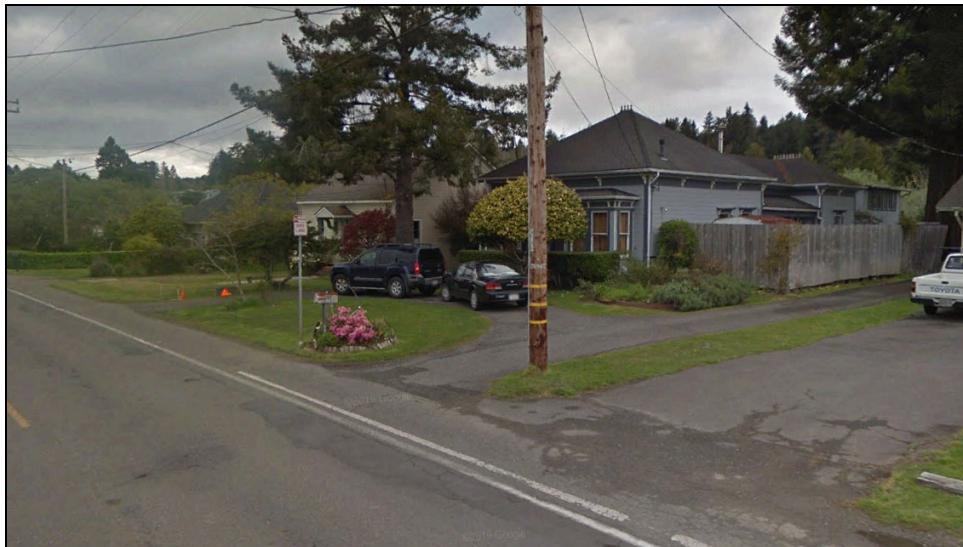
Photograph 4: 1752 Old Arcata Road (Google Earth, Imagery Date 4/2019), facing north.

The Nellist-Zucar-Smith House was built circa 1889 and located at 1752 Old Arcata Road (**Photograph 4**).

When Hedlund recorded this property as 9-05, he observed that this multi-part Folk Victorian house was likely built in phases. Sitting on an irregular rectangular plan, the house incorporates a pyramid roof on the front building. Its east wall is bisected by a T-shape gable roof with north-south hipped sections. Overall, the rectangular plan is flanked on the north and south sides by shed roof extensions. A flat-roofed structure is visible at the rear and includes vertical ribbon windows. Hedlund briefly describes the facade's character-defining features as "[bay] windows at front [that] are joined by a roof, all of which together form a recessed front entrance...Both porch roof and main roof have boxed cornice and frieze, with ornamental bracket trim."¹³ The house is set back from the roadway approximately 35 feet. Its front yard features a semi-

circular paved driveway, lawn, and some trees. It is unclear when the current front yard features were installed. The Hedlund recordation in 1978 notes that a white picket fence was in the front yard, but does not indicate the existence of the circular driveway. So, it appears that the current layout of the front yard has occurred within the past forty years. Thus, in addition to the design of the house, only a landscaped setback from Old Arcata Road is considered character defining for purposes of this report.

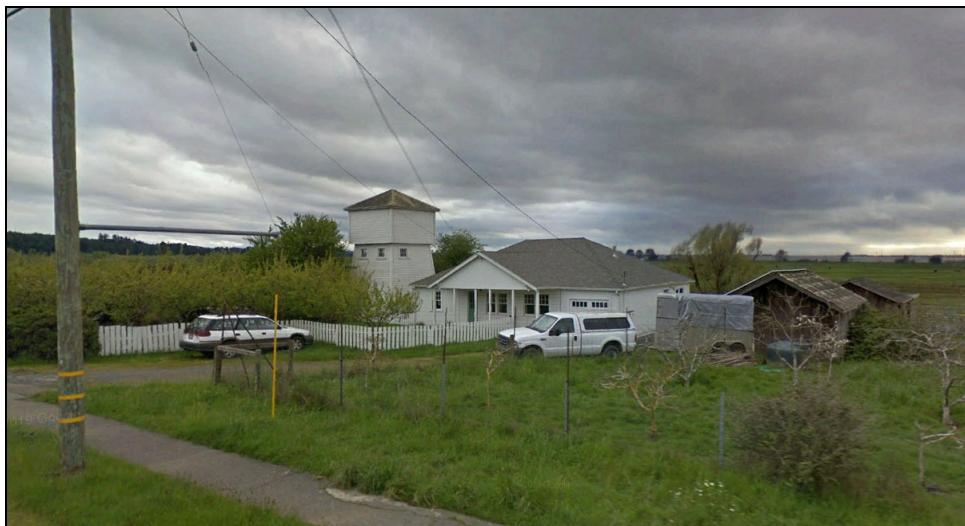
Photograph 5: 1401 Old Arcata Road (Google Earth, Imagery Date 4/2019), facing southwest.

The Rhodes-Marsh House & Trinidad Water Tower Complex (P-12-003681, Hedlund 9-14) is located at 1401 Old Arcata Road (**Photograph 5**). Built in 1930 and set back from the road, the house is a folk structure with Neoclassical details. Hedlund describes the house as covered with “shiplap siding” and “two sash plan molding windows with lugsills, one sash and transom.”¹⁶ The house’s hipped pyramid composite shingle roof has small eaves and features a cross gable pedimented porch supported by square posts. That porch shelters double-hung multi-light windows and an off-center front door. The house is entirely sided with horizontal wood and includes an attached double-door garage.

The three-story water tower is sided with shiplap and six-light fixed windows. Like the house, it has a pyramid shingle roof. The property also has two wood-sided front gable sheds located north and northwest of the house. Both the house and water tower were recorded in Hedlund’s 1978 survey, and the OHP data file notes the house was determined ineligible in 1979.¹⁷

For purposes of this report, the property’s character-defining features include the house and water tower’s design, along with the front yard that includes orchard trees, a picket fence, and unpaved driveway. There is also a sidewalk and mow strip in front of this house, separated from the front yard by a hedge and a fence. Thus, the sidewalk and mow strip are not considered part of the character of this property. It is unclear whether the sidewalk and mow strip are located within the road right of way.

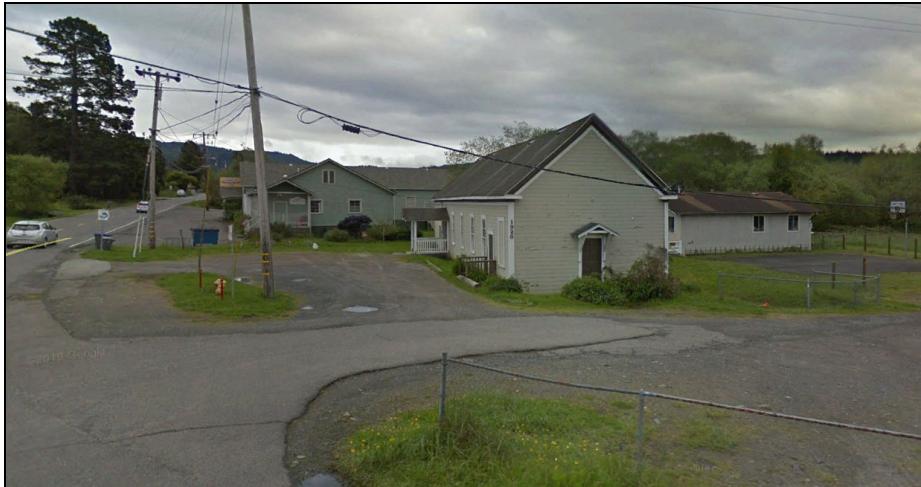
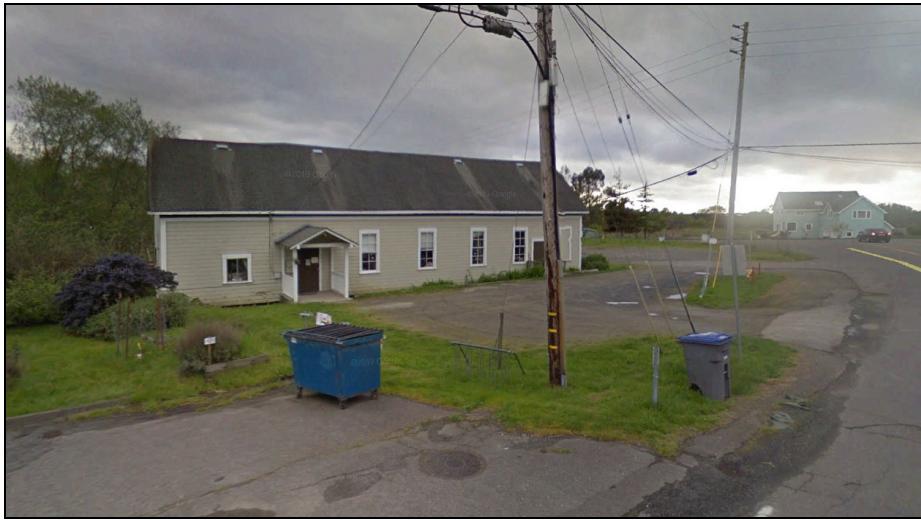
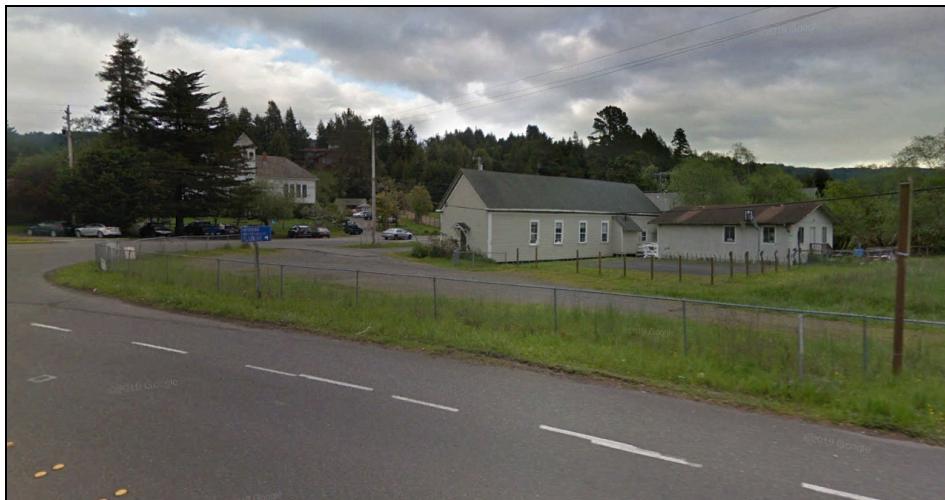
Photograph 6: 1928 Old Arcata Road (Google Earth, Imagery Date 4/2019), facing southeast.

Photograph 7: 1928 Old Arcata Road (Google Earth, Imagery Date 4/2019), facing west.

Photograph 8: 1928 Old Arcata Road (Google Earth, Imagery Date 4/2019), facing east.

While Van Kirk did not describe the building’s character-defining features, they were noted by JRP during the desktop review. Designed in a vernacular style, the rectangular-plan building rests on a raised foundation on an angled grade. The former community hall is topped with a steeply pitched composite shingle front gable roof and its narrow, closed eaves highlight a modest entablature of undecorated frieze and a typical architrave line.¹⁹ Built into a gentle slope, the hall is generally unadorned and covered with horizontal wood siding. The original northwest-facing entry is shaded by a small exposed rafter gable porch roof supported by brackets. The east side of the hall includes two entrances: a wood door accessed by downward steps on the northern end, and another wood door reached from the parking lot by elevated concrete and shaded by a gable roof porch. Research did not determine whether these west side entrances are original.

JRP’s desktop review observed that modifications have been made to the building’s vernacular exterior that impact its integrity. Windows include four-over-four vinyl replacement sashes, a shed roof projection has been added to the west wall, and an elevated walkway with wood railings projects from the west wall to connect the hall to a gable-roofed building that appears to have been constructed in the latter twentieth century. There is a small playground behind (east of) this newer building.

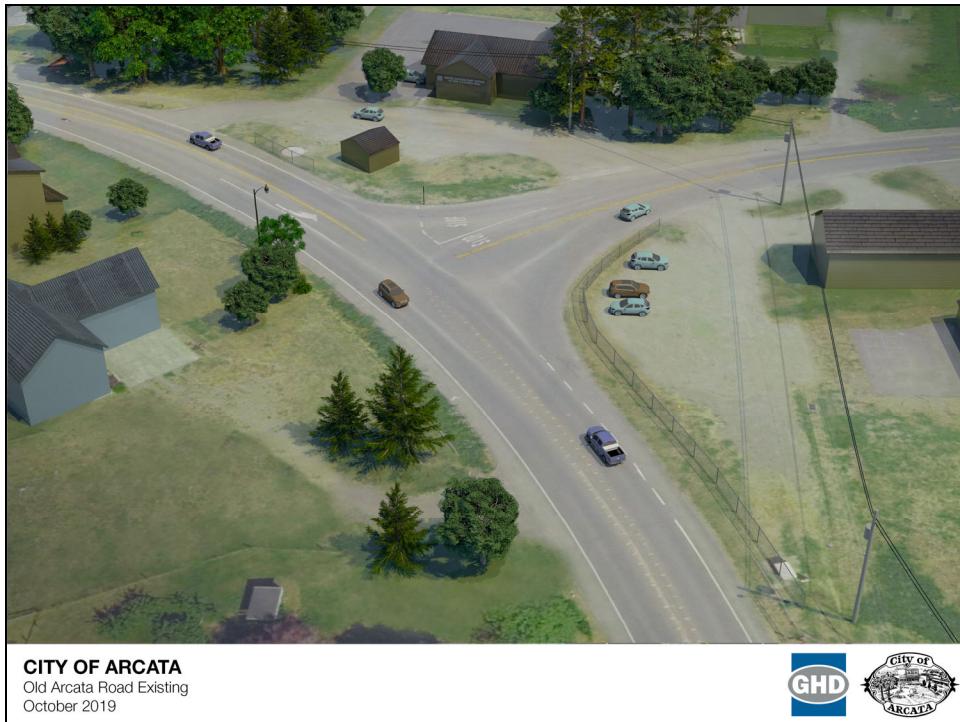
Figure 1: Rendering of Existing Intersection of Old Arcata Road and Jacoby Creek Road.
Mistwood Education Center is on the right side of this image. No other known or potential historical resources are depicted.

The proposed roundabout would reconfigure the intersection of Old Arcata Road and Jacoby Creek Road (**Figure 1** and **Figure 2**). It would also include the same road improvements noted above, including widening Old Arcata Road within the road right of way, construction of new sidewalks, improvements for bicycles, and paving driveway approaches.

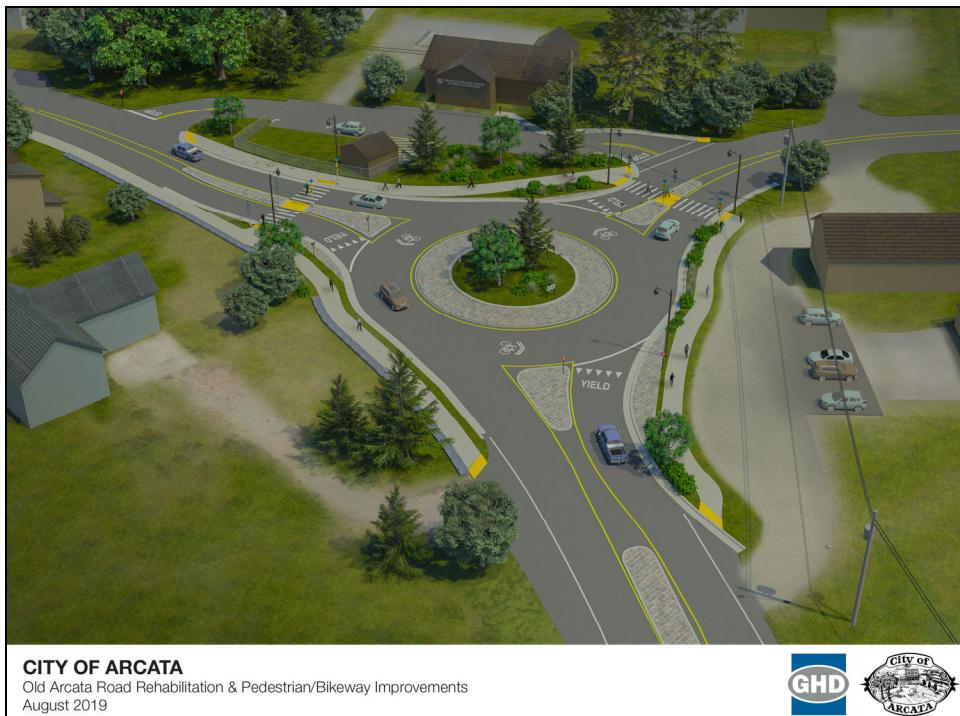
Figure 2: Rendering of the Proposed Roundabout at the Intersection of Old Arcata Road and Jacoby Creek Road
