Bayview Neighborhood Survey

College of the Redwoods

CT 12 Historic Research & Documentation

Spring 2006

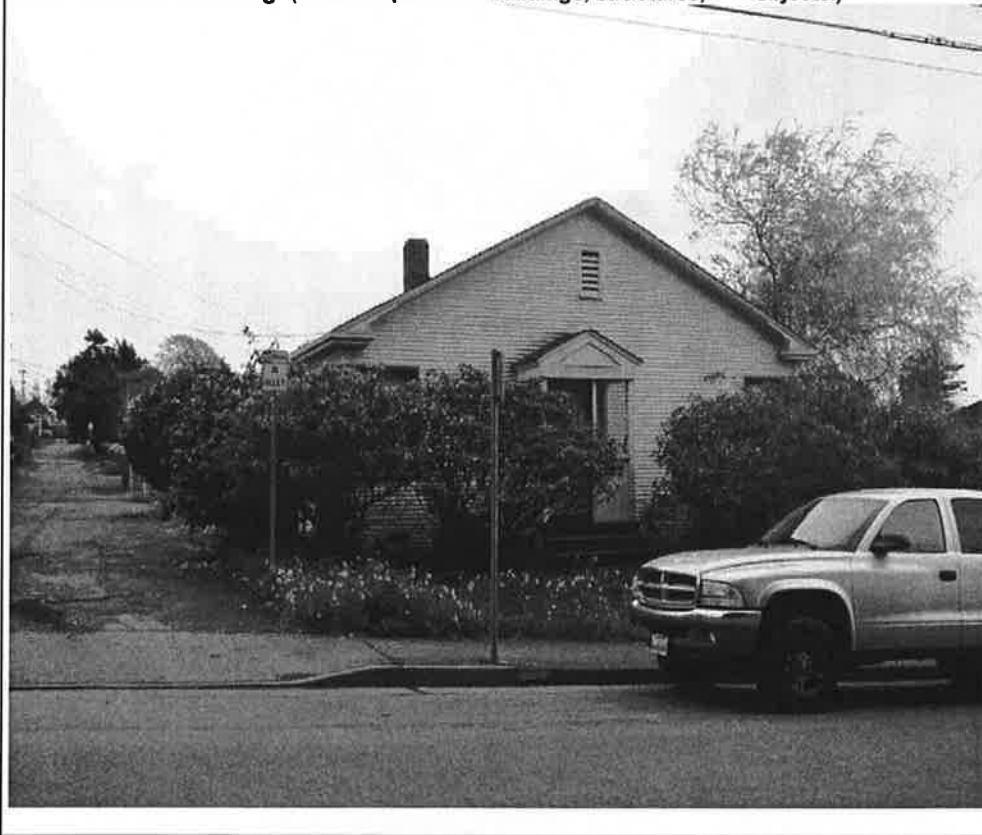
P5a. Photo or Drawing (Photo required for buildings, structures, and objects.)

*P3a. Description: (Describe resource and its major elements. Include design, materials, condition, alterations, size, setting, and boundaries) This small 1940 bungalow is a style single-family house is located across from HSU campus. It is similar to the two houses to the west on D Street. It appears to be a 2-bedroom house. Large rhododendrons obscure the front of the house. Parking for 3 cars, is accessed from the alley. The garage has been enclosed and a small garden space is behind the house. This minimal traditional with closed soffit eave returns and very narrow wood siding painted beige, a small front porch with the lower part enclosed and facing north with a gable roof, 2 original window facing east, all other windows have been replaced with anodized sliders. The rear porch has as an overhang supported by knee braces. Perimeter foundation, metal gutters, & asphalt roofing exist. Condition is good. Boundaries: Between alley and D. Streets.

Front, 3/19/06

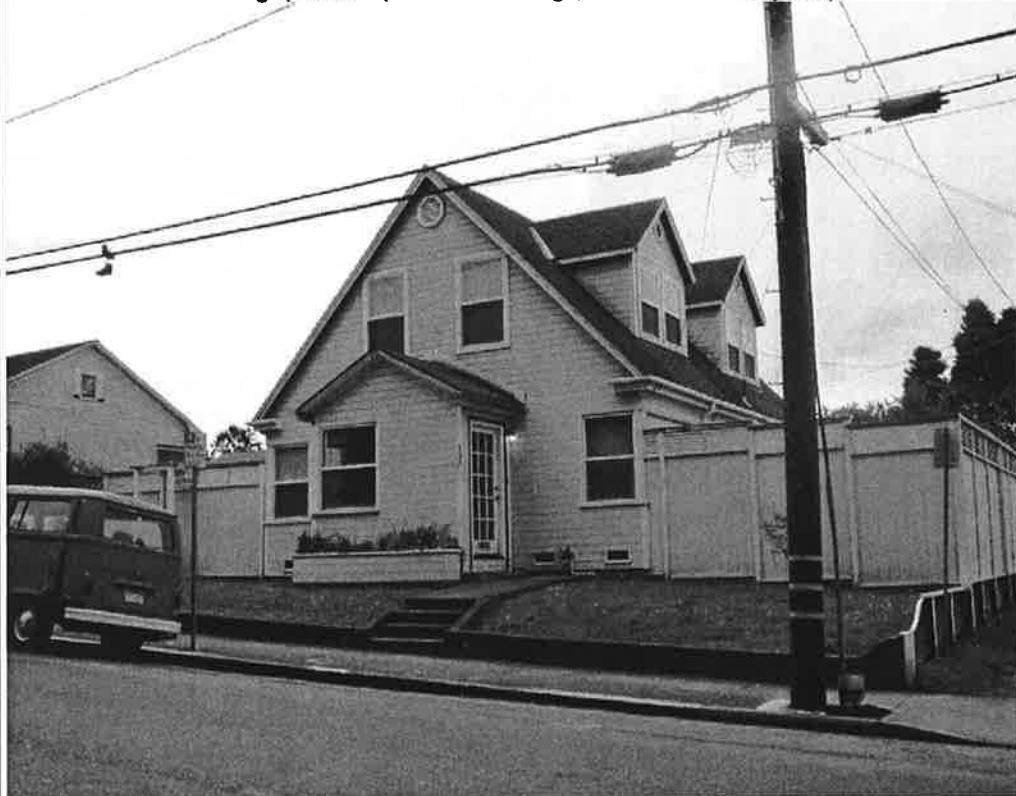
P5a. Photo or Drawing (Photo required for buildings, structures, and objects.)

***P3a. Description:** (Describe resource and its major elements. Include design, materials, condition, alterations, size, setting, and boundaries) This appears to have been a small bungalow as the one across the alley to the west at 361-14th St.. These houses have the same soffit returns, porch placement and first floor window arrangement and both had garages off the alley.

This house has been enlarged and the roof was raised, dormers added to the east and west, windows replaced, new siding, front porch enclosed with a new entry door off the walkway and 2-windows. The yard to the east and west is enclosed with a 6+ foot fence, several bay windows have been added to the south and west elevations at the rear of the house. Perimeter foundation, metal gutters, & asphalt roofing. The parking is off the alley. This pink house is student housing and is located to the south of the HSU campus on 14th Street. Condition is good. Boundaries: Between alley and C Street.

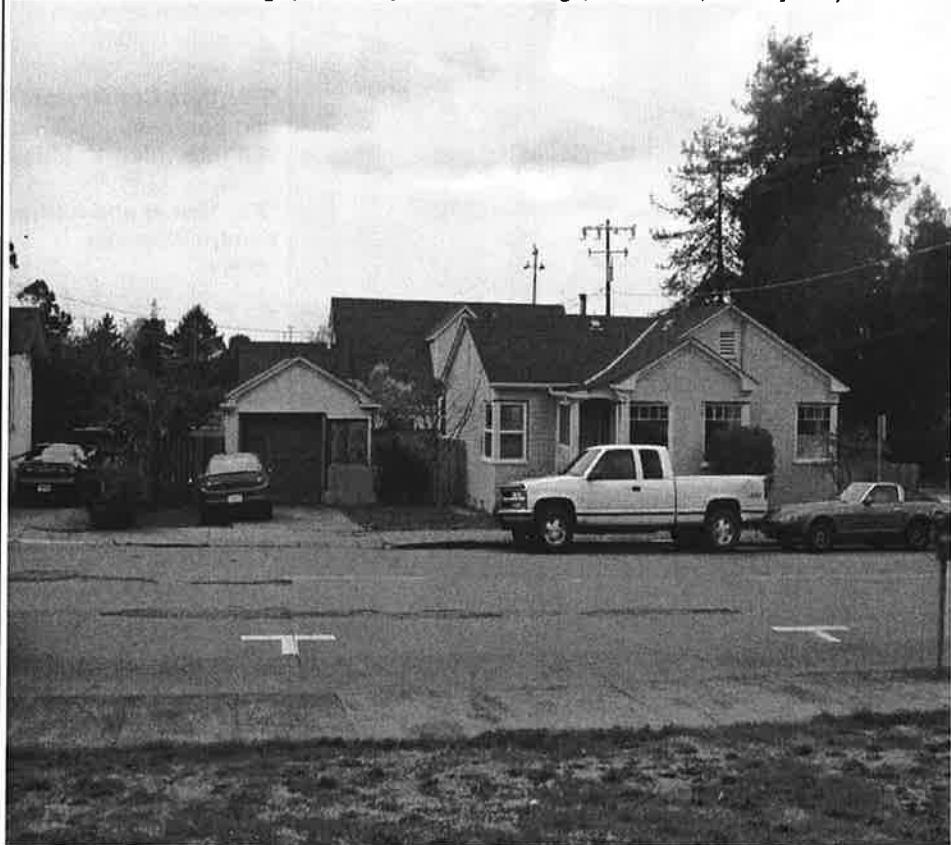
P5a. Photo or Drawing (Photo required for buildings, structures, and objects.)

*P3a. Description: (Describe resource and its major elements. Include design, materials, condition, alterations, size, setting, and boundaries) This 1940 house is occupied by its owner, who has lived there for the past 7 years. The owner has slowly been repairing the exterior of the house by removing siding from the garage. Eventually, he will remove the garage and replace it with a new one. He states the existing garage is rotten. The house is a small single story with wooden siding and replacement windows. The front windows have divided lights at the top and a single light below. It has eave returns, a small stoop with the entry door facing south. Two cars can park on the concrete apron in front of the garage. The owners landscaped the yard. The entrance is enclosed and is accessed by a stairs to the left of the stoop. Attic roof vent faces east, chimney has been removed and a metal pipe protrudes from the roof. The roof design is low gable with black asphalt shingles. Minimal traditional which is prevalent in this block. All four corners of the house have paired corner windows, which are seen on other houses in the area. The front protruding gable is part of the livingroom and the front door enters through this porch, has paired corners windows too. Wooden shiplap siding butts into the corner boards. Return eaves are another feature found throughout this block.

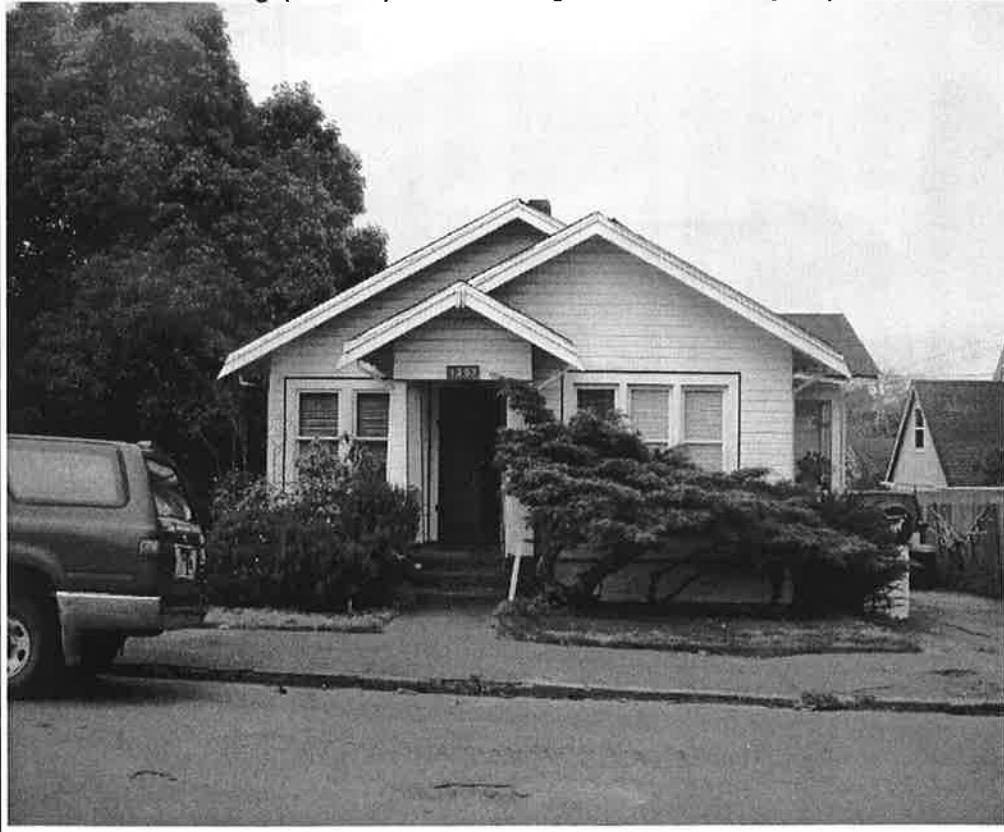
P5a. Photo or Drawing (Photo required for buildings, structures, and objects.)

*P3a. Description: (Describe resource and its major elements. Include design, materials, condition, alterations, size, setting, and boundaries) Its owner occupies the small 1936 bungalow that is locally known as Irish House. It is a small single story building with wooden siding, metal gutters/downspouts and replacement windows. The entry is a small off center stoop facing south. The single concrete driveway is to the north of the house. The garage is in original condition and can be approached from C Street as well as the alley. A small yard with older planters is to the south of the garage. A fence exists between the alley and the set back garage. It could become a second unit on the property. Major elements include gable roofs with black asphalt shingles. Condition: good, gutter on south side needs attention. The house appears to be a two-room bungalow. Boundaries: middle of the block on C Street between 13th and 14th Sts.

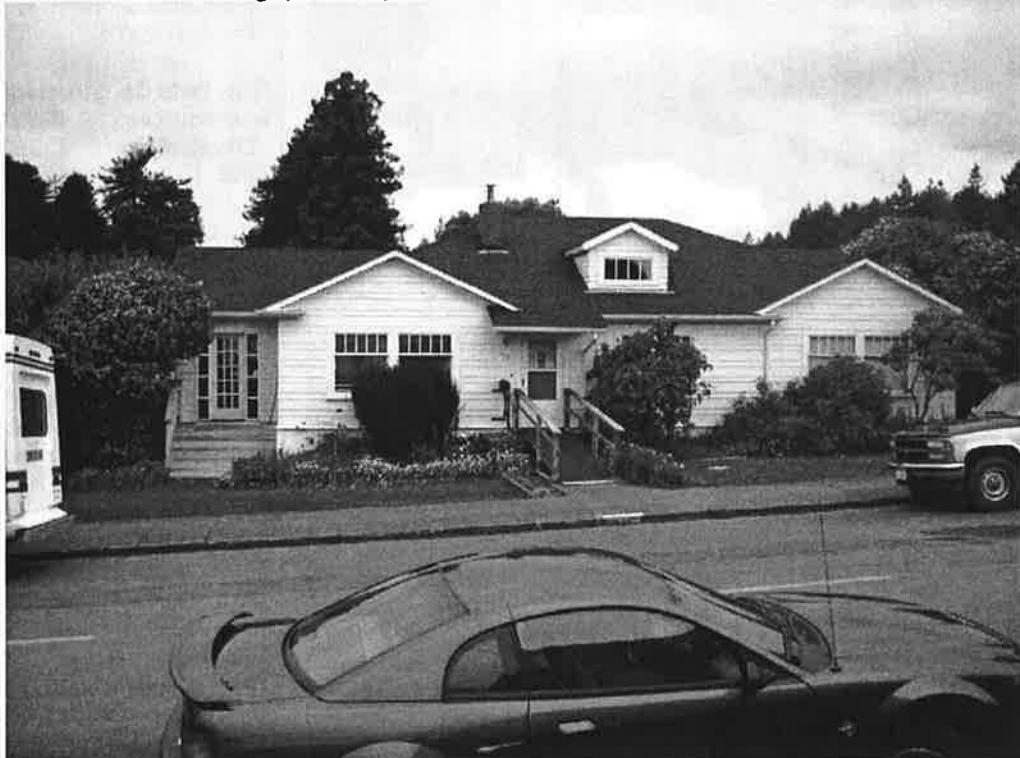
***P3a. Description:** (Describe resource and its major elements. Include design, materials, condition, alterations, size, setting, and boundaries) Historically known as the Arnold House, this Post World War II minimal traditional house is a single story residence with no garage and a large north yard that currently is well gardened (visible from C Street). The siding is a double lap horizontal wooden siding pattern with a wide board, then narrow board combination. The small covered entry stoop has a roof overhang with a centered front door covered by a screen door. A gabled dormer vent faces south, a brick chimney to the east of it has a metal stove pipe insert, and the roof has asphalt shingles with a multiple roof line, indicating several changes through time. The Craftsman styled front windows have divided lites at the top and a single large pane below. The gutters and downspouts are metal, and foundation, steps, walkways are all concrete. A west entrance door has a fifteen light door with two, four-lite sidelites, accessed by a wooden stairway.

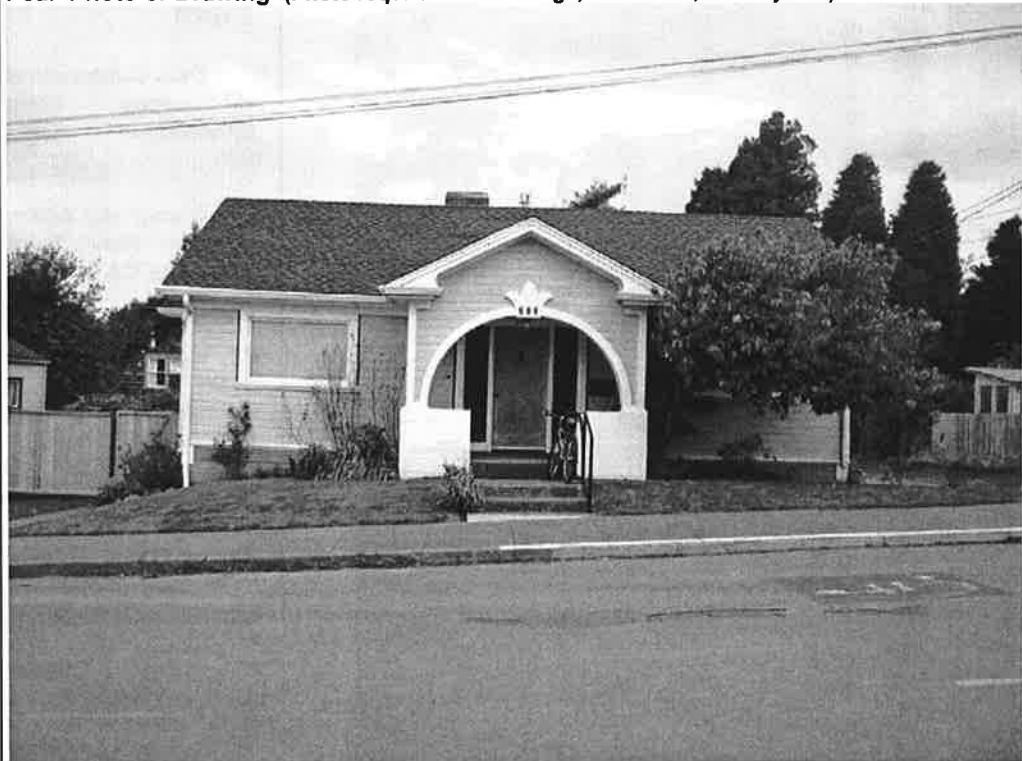
P5a. Photo or Drawing (Photo required for buildings, structures, and objects.)

Known as the Sorenson house, this minimal traditional single story was built in 1931 as a residence with an attached garage and other additions in the alley. It is located in a single-family neighborhood next to HSU and is currently rental housing. Pre-World War II house with V-rustic wood siding, a stucco front porch enclosure with an arched porch entry decorated with arched eave returns. The front entrance is in the center of the south facing facade, with a solid wood door with full sidelites made of architectural clear glass. There are older Camilia tree to the east of the front door. Porch is front facing with closed soffit return eaves, arched entry and. Carpet on the concrete porch. Perimeter foundation. Metal gutters and downspouts, original windows. Chimney & new wooden fence to west of house. Garage is off the alley along with other enclosed spaces. This house is in good condition and sets on one of the larger lots lot size in this block. Setting: Adjacent to the alley on 13th Street and near HSU and the D. Street Neighborhood Community Center.

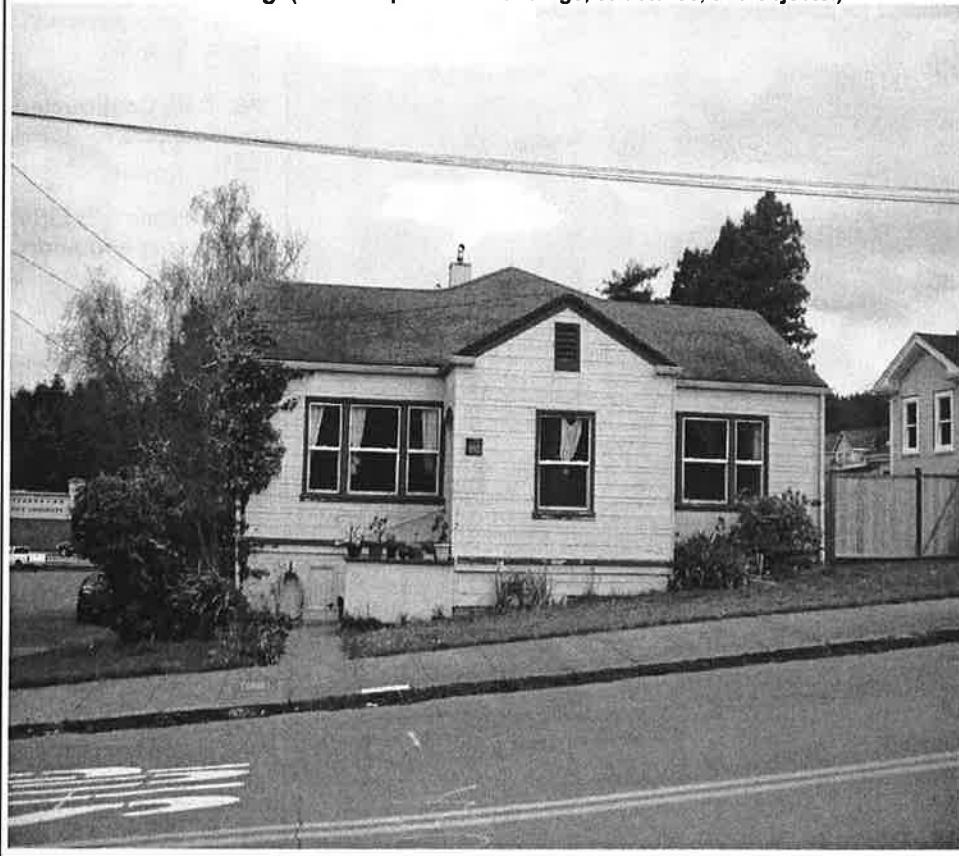
P5a. Photo or Drawing (Photo required for buildings, structures, and objects.)

*P3a. Description: (Describe resource and its major elements. Include design, materials, condition, alterations, size, setting, and boundaries) Pre-World War II house. Single story residence with an attached garage. The wooden siding is a double-lap horizontal pattern and needs to be repainted. The entrance is enclosed and is accessed by a staircase to the left of the stoop. The small covered stoop has an archway and the door is straight ahead. The projecting bay has a vinyl window facing the street. A large attic roof vent faces south, stucco chimney, and the roof has asphalt shingles and is a low center hip with two gables facing east and west. The windows to the west are in a group of three with the center window being the largest. It appears to be the same on the east side of porch except one of the smaller windows is missing. The windows on the south are white vinyl and the other windows are the originals double hung single glazed. The eaves have returns. The gutters and downspouts are metal.

P5b. Description of Photo: (View, date, accession #) Front, 3/19/06

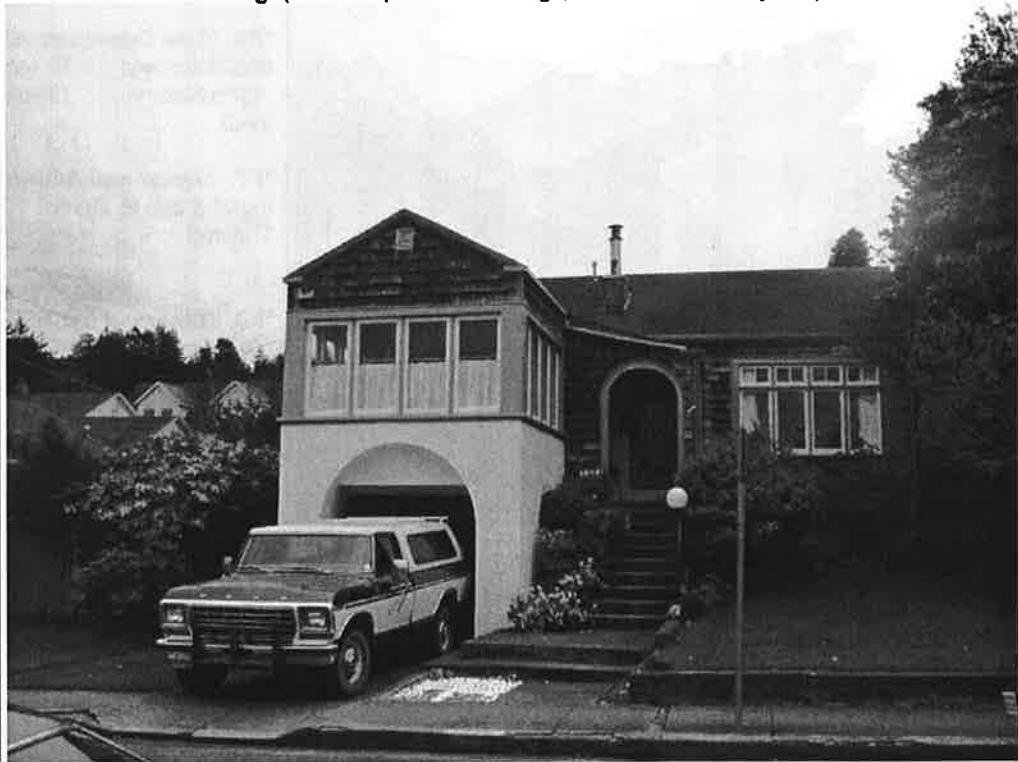
P5a. Photo or Drawing (Photo required for buildings, structures, and objects.)

*P3a. **Description:** (Describe resource and its major elements. Include design, materials, condition, alterations, size, setting, and boundaries) Owner occupied, it was built as a residence with the single car garage underthe north part of the house. The house is reached by a set of 10 concrete steps from a 2-step concrete landing. The property can also be accessed from the alley. There is a storage building in the back yard, matching the house materials, a lean-to structure for firewood to the north and an aluminum structure for camper parking to the north of the property on the alley. This World War II era house has been shingled, the garage area is stucco clad, the front full glass door is recessed and 3 fixed windows on the south wall of the porch allow light to pass through the front door which is enter through an archway facing west. The room above the garage appears to be a sunroom with a set of 4 windows on 3 sides, a set of 4 windows with divided lites to the right of the porch. The windows are all original. This minimal traditional has closed soffit eave returns, arched entry, concrete steps, perimeter foundation, metal gutters, shingle siding, original windows, a stovepipe protrudes from the chimney, asphalt roofing, with a small shed dormer facing east, cyclone fencing on alley. Condition is good. Boundaries are between 13th and 14th Streets

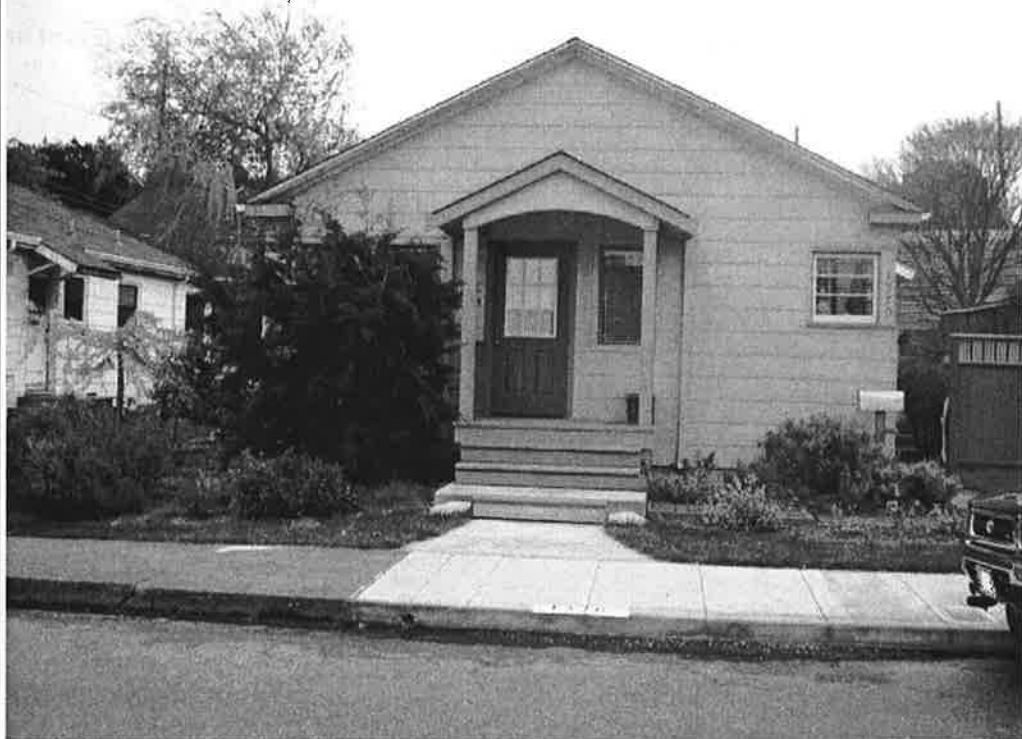
***P3a. Description:** (Describe resource and its major elements. Include design, materials, condition, alterations, size, setting, and boundaries) This 1940 gable roof bungalow is a minimal traditional style small single-family house located across the street from the D Street Neighborhood Community Center. It is similar to the two houses to the north and is in good condition. It appears to be a 2-bedroom house with closed soffit eave returns, a small gabled front porch facing west, the porch decking and steps are wood, the exterior has been covered in asbestos siding painted green. The front door and adjacent window are both new as the window to the north of porch; the corner-paired window to the south is original as the other south facing windows. Perimeter foundation, metal gutters, asphalt roofing, side porch with a projecting roof and double concrete steps and one parking space off the alley. The original garage door exists on the south façade and is on a sliding track. Boundaries are between 13th and 14th Streets

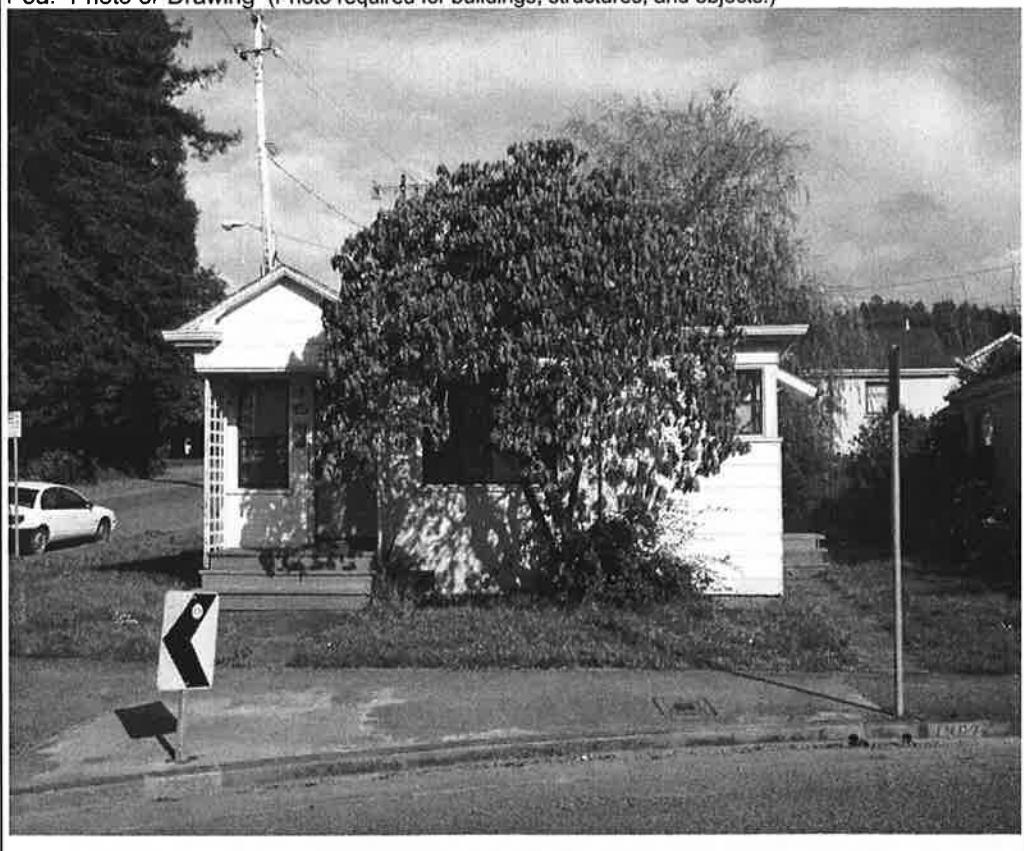
P5a. Photo or Drawing (Photo required for buildings, structures, and objects.)

Closed soffit eave returns, a small front porch with a gable roof facing west and at the northern corner of the house, the porch decking and steps are wood and a trellis is to the left of the front door, the exterior is in good condition and has been covered with asbestos siding and painted white. The front door and windows have been replaced. Perimeter foundation, metal gutters, & asphalt roofing exist.. Boundaries are on the corner of 14th and D Streets.

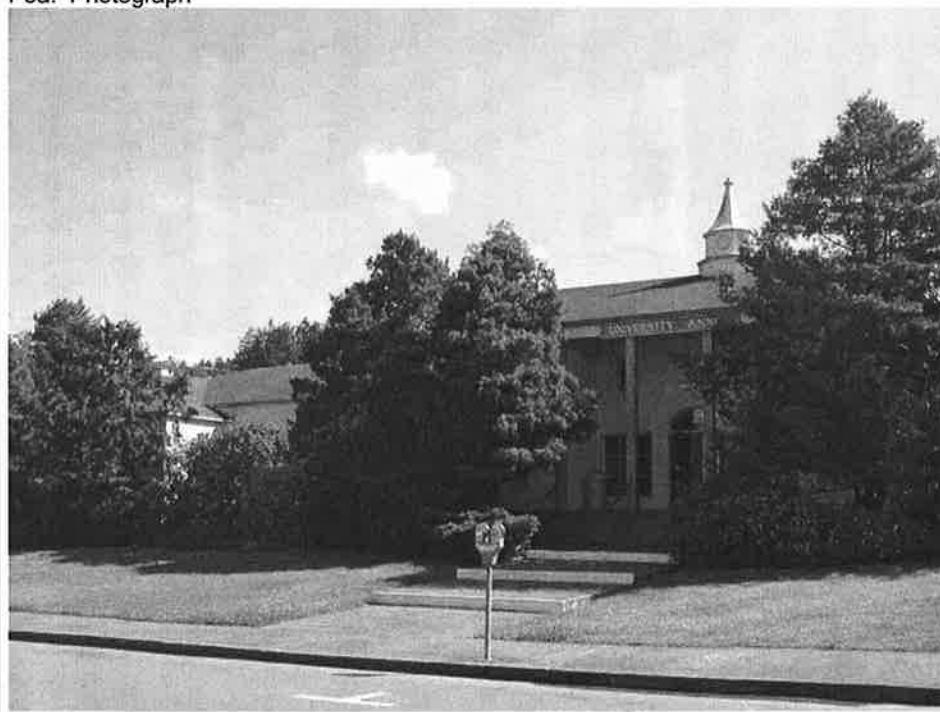
P5a. Photograph

The Trinity Hospital, now the Humboldt State University Annex, was started in 1943. It is in a Mission Style, and the alcoves in the front entry, off C street speak of statues placed there by the Sisters of Orange during this building's original life. The Hospital Building had several additions and/or changes but other than those, the entire block is taken up by the Hospital complex. Being a public building it did not have a particular relationship with surrounding architecture though elements of style were found in nearby residences (particularly the rabbeted two-step lap siding). The separate buildings formed courtyards, connecting walkways and a central parking area. The vegetation in the front (west elevation) has grown over the years with a collection of rhododendrons, azaleas and camellias. These have become overgrown, covering the front windows and obstructing the style of the building. This building is an excellent candidate for rehabilitation as the building is in good physical condition and demonstrates a great potential for making its living by leasing or renting out interior spaces, rooms, etc. Additions occurred in 1947 and 1948

P5b. Description of Photo:
 Front, 3/19/06

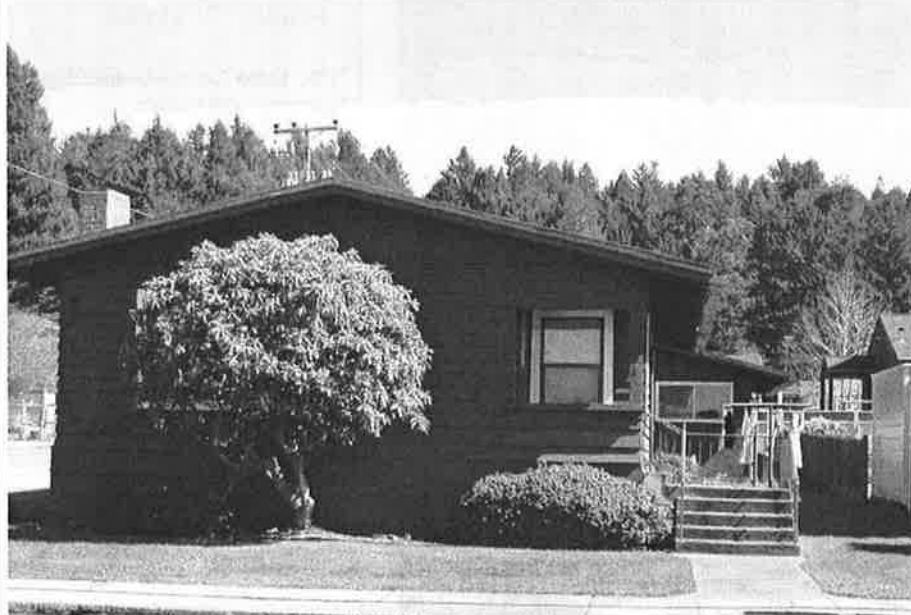
Front, 3/19/06

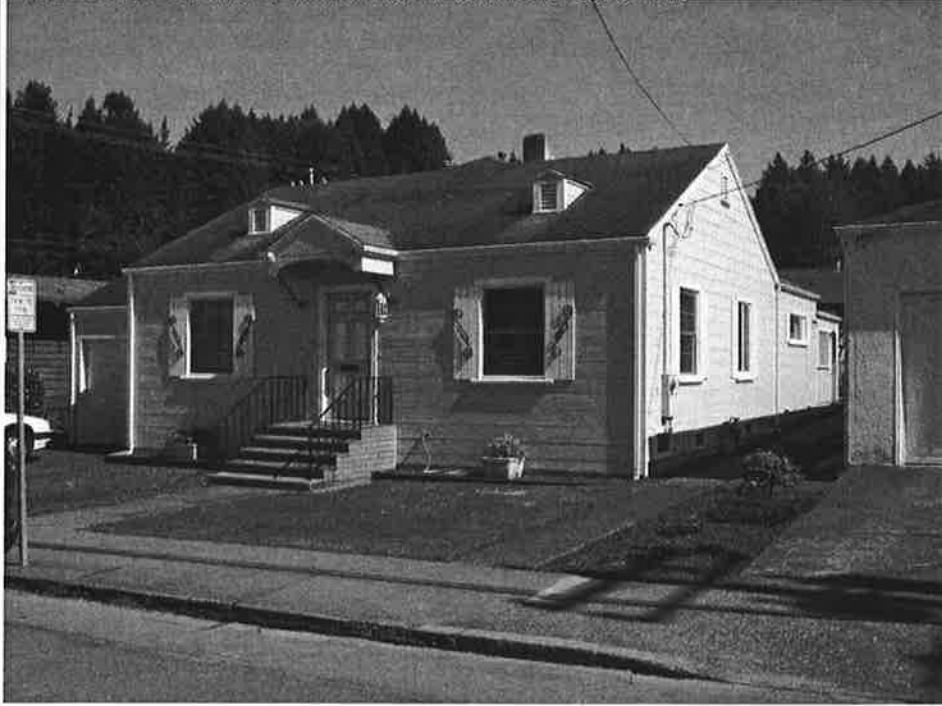
P5a. Photo or Drawing (Photo required for buildings, structures, and

***P3a. Description:** (Describe resource and its major elements. Include design, materials, condition, alterations, size, setting, and boundaries) Minimal Traditional style circa 1940 house with small eaves, composition shingles, medium-pitched side gabled roof, and horizontal wood siding. There is an attached single-car garage on side of residence. Two symmetrical dormer roof vents face towards the front. Rear facing gable on back of residence with add-on room on southeastern corner. Entrance centered with covered stoop and decorative metal work under stoop roof, matching design on metal railings and wooden decorative window shutters. Vinyl hung windows and metal gutters and downspouts. Concrete walkway leading directly from front sidewalk. Two add-ons to residence, one at the southeastern corner and on behind the garage with small access door facing the street. Shed and large landscaped patio in back as noted for 1398 B St. There is a twelve foot wide pan handle strip accessing 14th Street to the north. A Gate in the fencing allows access.

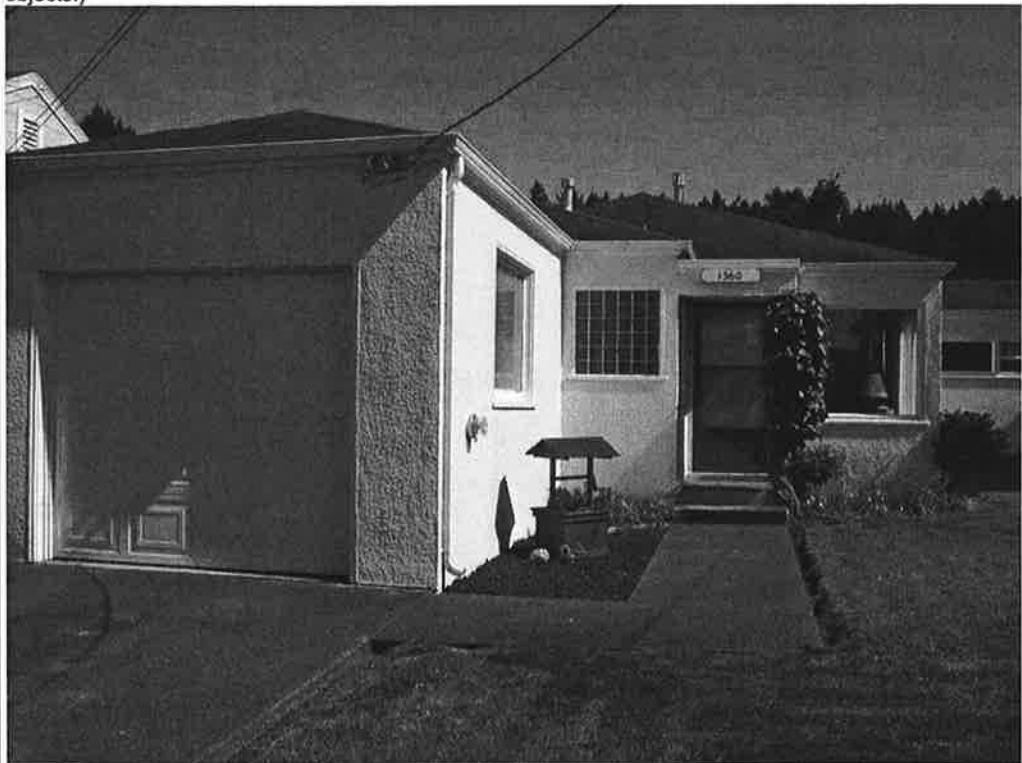
P5a. Photo or Drawing (Photo required for buildings, structures, and objects.)

This 1950 minimal traditional house is stucco-clad, with a composition shingles, shallow eaves, and a low pitch hipped roof. There is a single car attached garage on the front. Entry is offset to the south with an uncovered stoop, and a decorative glass block window north of the front door. The plan of the house is an L-shape, with multiple intersecting roof lines. There is a shed in the back of the property with a gabled roof. Appears in good condition.

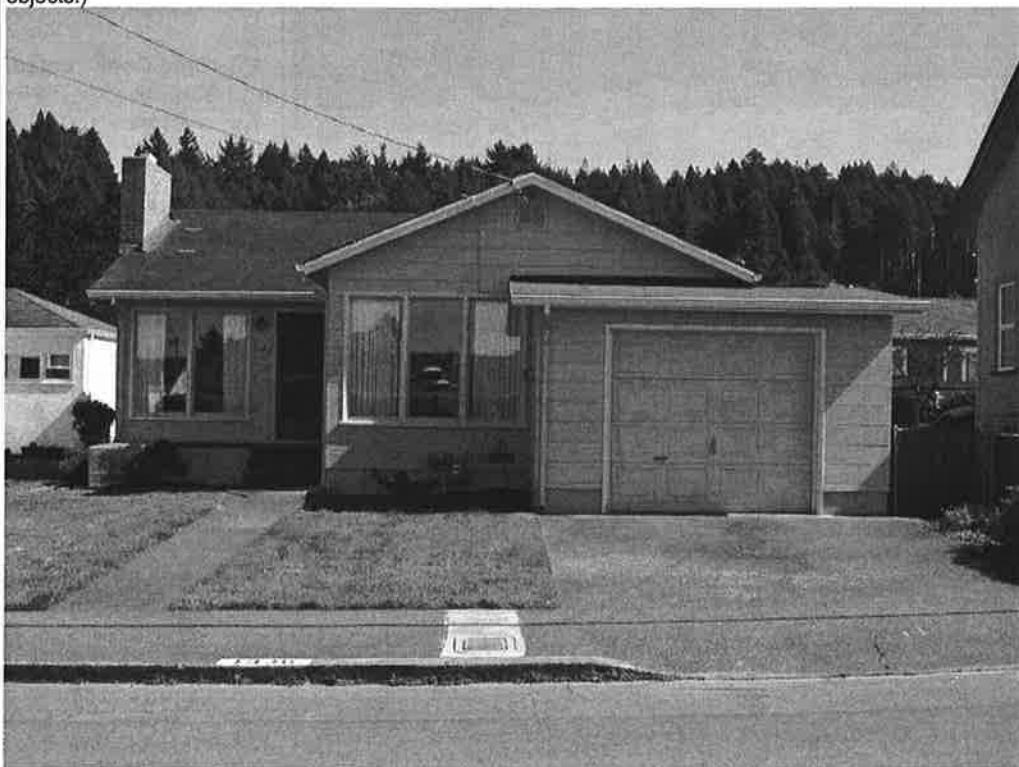
P5a. Photo or Drawing (Photo required for buildings, structures, and objects.)

Built in 1950 as a small Ranch Style, cross-gabled home with projecting shed roofed garage. All of the houses on this block have 16 panels on the garage doors. A concrete walk with lawn on either side, leads to an uncovered concrete stoop. The wood siding is painted beige, and there is a small eave with a metal gutter attached, and metal down spouts. There is a concrete foundation and shed in back. House appeared in good condition. Wood framed windows with dividing mullions on front elevation. Chimney built onto North elevation is original.

P5b. Description of Photo:
(View, date, accession #)
Front, 3/19/06

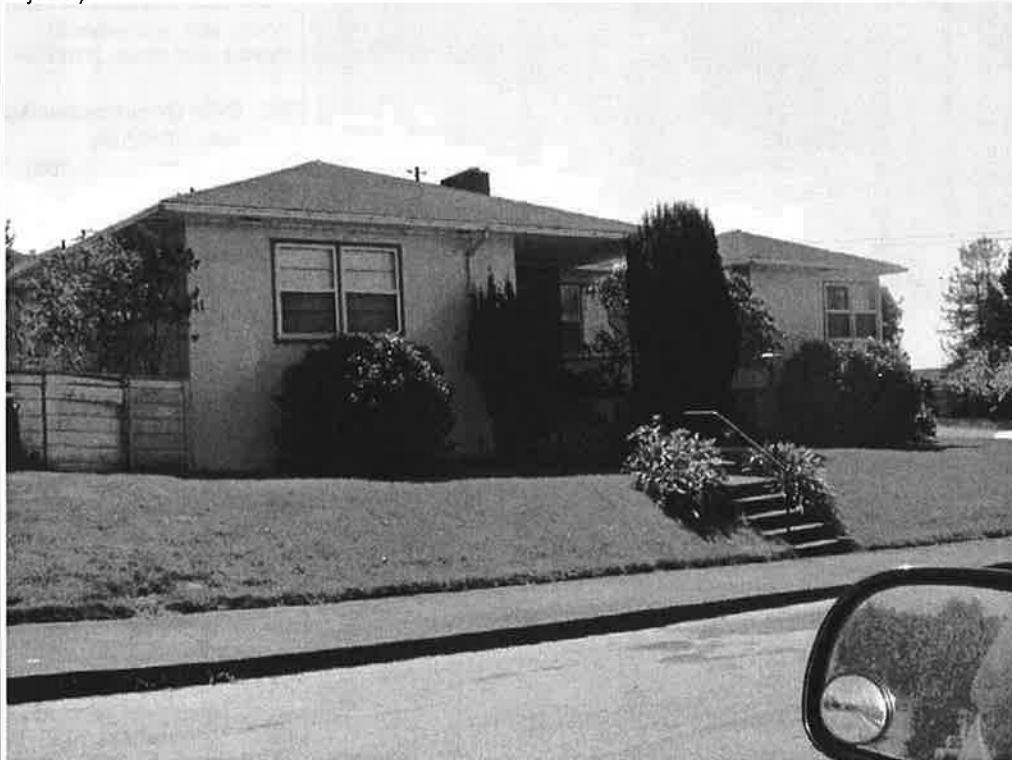
P5a. Photo or Drawing (Photo required for buildings, structures, and objects.)

*P3a. Description: (Describe resource and its major elements. Include design, materials, condition, alterations, size, setting, and boundaries) This stucco house sits on a raised lot on the corner of 13th and D Streets. A recessed entry is slightly offset to the east and is fronted by a brick stairway, a concrete landing and stairway that meets the front sidewalk. The solid wooden front door has a full-length glass sidelight. The brick skirting on the west portion of the house extends to the double car garage on the west elevation. The garage has multiple windows in the upper panels of the roll-up doors. A west facing side entry is reached from a set of concrete steps and a stoop. The paired windows on the north elevation are covered with white vinyl screens. A large brick chimney extends through the roof in the western center of the house. A low hipped roof is covered in composition shingles. A new detached building can be seen adjacent to the west-facing garage.

P5b. Description of Photo:
(View, date, accession #)
Front, 3/19/2006

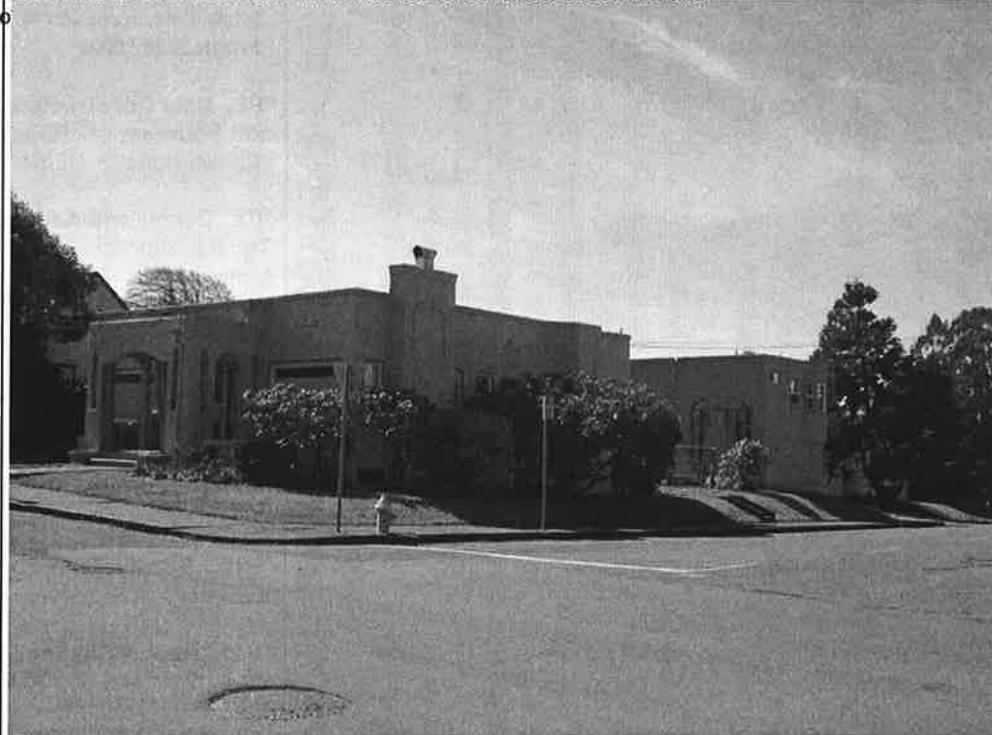
P5a. **Photo or Drawing:** (Photo required for buildings, structures, and

*P3a. **Description:** (Describe resource and its major elements. Include design, materials, condition, alterations, size, setting, and boundaries)
Historically known as the Paul Cates house. Built in 1929, this is a Spanish style house with a center portico that extends beyond the covered area on either side of entryway. The entry is a single glass & wood door and is flanked by sidelights. The Portico has wood columns and an arched front and sides. House sits on a corner lot close to the front sidewalk. A similar style detached apartment over a two car garage was added within the last 2 years. Stylistic consistency is evident between the house and the apt., although vinyl windows are installed and the stucco pattern is of a different texture on the apt. Lot is bordered by sidewalks on C and 13th streets and an alley on the west. The north side of house has an exterior chimney and a bay window. All windows in the main house have wood casings. The west side of the house has a door and a small stoop that leads down to the ground level. The south side of house has several large bushes and a six to seven foot wood fence that runs from the western edge of the lot to the back wall of the house. The south side yard is narrow with a concrete pathway that runs the length of the house.

(View, date, accession #)
Front & side views, 3/19/2006

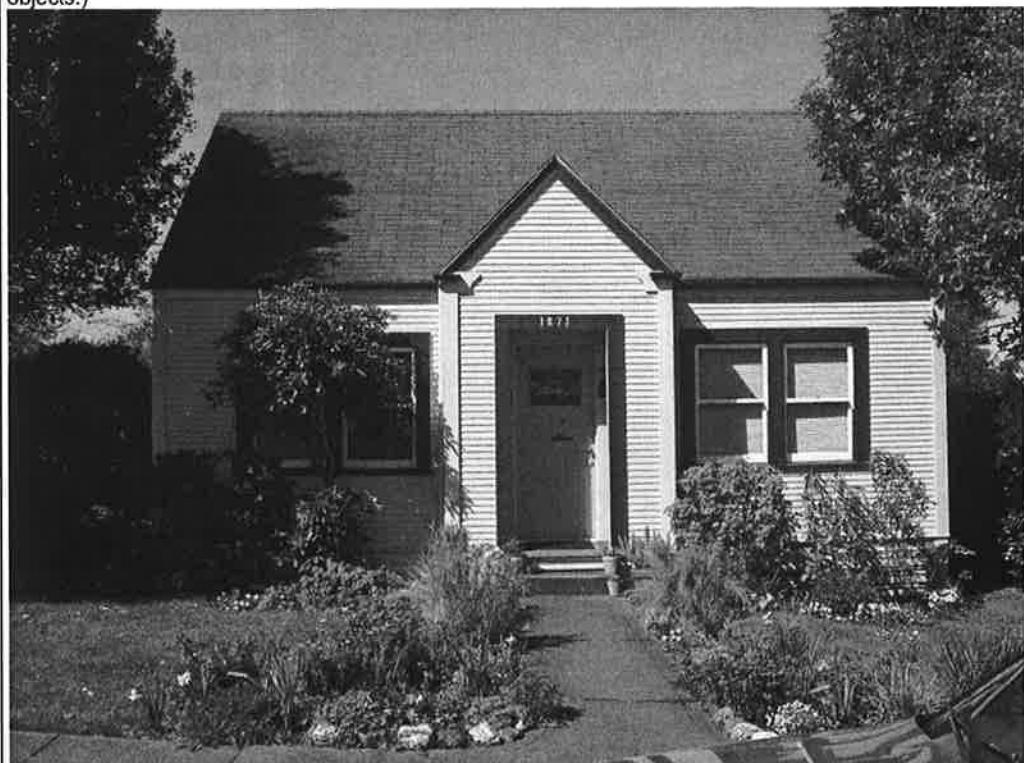
P5a. Photo or Drawing (Photo required for buildings, structures, and objects.)

*P3a. Description: (Describe resource and its major elements. Include design, materials, condition, alterations, size, setting, and boundaries) Small minimal traditional house built in 1941. House is set back from the sidewalk about 12' and is centered on the lot with small side yards on the north and south sides. Steep roof line runs north and south with flat gabled ends on each side. Roofing material is composite shingle over a previous wood shingle and appears to be in good shape. Wood gutters on both front and back of house. Small front lawn with a concrete path that leads from the sidewalk to the entry door, which is centered with a small gabled stoop. Two 1 over 1 windows set in wood casings are placed symmetrically on each side of the entry. House has false beveled wood siding that exemplifies its minimal traditional style. Three 1 over 1 windows are located on side elevations beneath large flat gabled sides with eave returns. A mother-in-law unit is visible from the west elevation, runs along the property's north boundary and is set back from the alleyway. This unit has a dutch hip roof that faces the west and two step rabbited siding. Unit appears to be added onto the back of a prior addition and exhibits the same siding as the original house.

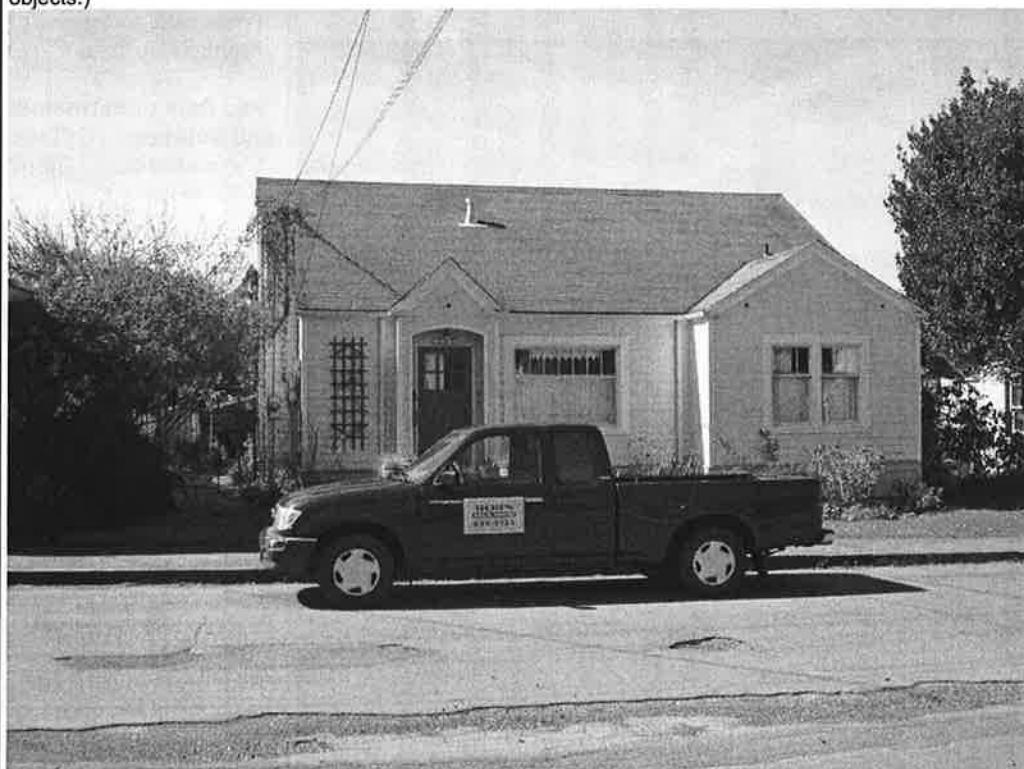
P5a. Photo or Drawing: (Photo required for buildings, structures, and objects.)

***P3a. Description:** (Describe resource and its major elements. Include design, materials, condition, alterations, size, setting, and boundaries) Built in 1940 and historically known as the Todd House. A minimal traditional 1½ story house set back from the sidewalk approx. 12'. It has a small lawn across the front (east) elevation. This elevation has a recessed and gabled entryway, offset to the south, framing a red wood door with a six pane window. The entryway is joined to the front sidewalk by a concrete pathway. The house has wood siding, painted yellow with white trim. Steep roofline runs north and south, is covered in composite shingles and has gabled ends with eave returns. The north and south elevations are gabled with two 3 over 1 windows in the center of the first floor and on the upper ½ story of the north elevation. There is a small side yard with shrubbery separating it from the adjacent property to the north. The south side of the house has a small side yard with a concrete path that leads from the front entry around the south end, to a back yard. Windows are original and vary in size. The west elevation has a centered gable balanced by a dormer window on each side. A back yard lies between the house and a detached 2-car garage. The garage is in the same style as the main house, opens to the west and onto an alley that runs along this back elevation. The house exemplifies its' original integrity.

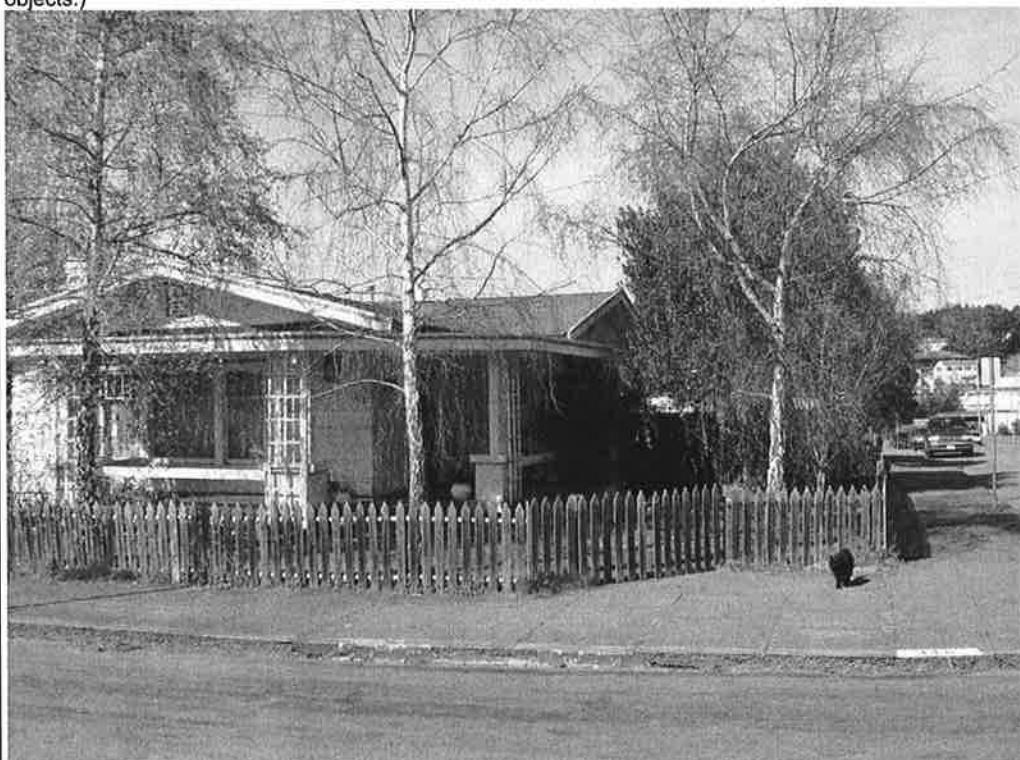
*P3a. Description: (Describe resource and its major elements. Include design, materials, condition, alterations, size, setting, and boundaries) Built in 1923 in the craftsman bungalow style and historically known as the Lundborg House. This home has boxed soffits and double lapped siding painted a pale yellow with white trim. An open, covered front porch wraps around the southeast corner of the house. The porch has square wood columns and a concrete floor. Front entry is on the east side of the porch and a large three section window is on the south side. A concrete pathway joins the porch corner to the sidewalk. The house sits on a post and peer foundation. Roof is a low gabled design and is covered in composition shingle. To the north of the house is a detached one-car garage that opens to C Street. An exterior chimney encased in stucco with a brick cap appears on the west elevation. The small side yard has a concrete path that runs from the sidewalk on 12th Street to the backyard. Rear entry is located at the north corner and is covered with a simple lean-to roof. There is an interior chimney to rear of the house. A simple low unfinished picket fence surrounds a portion of the property.

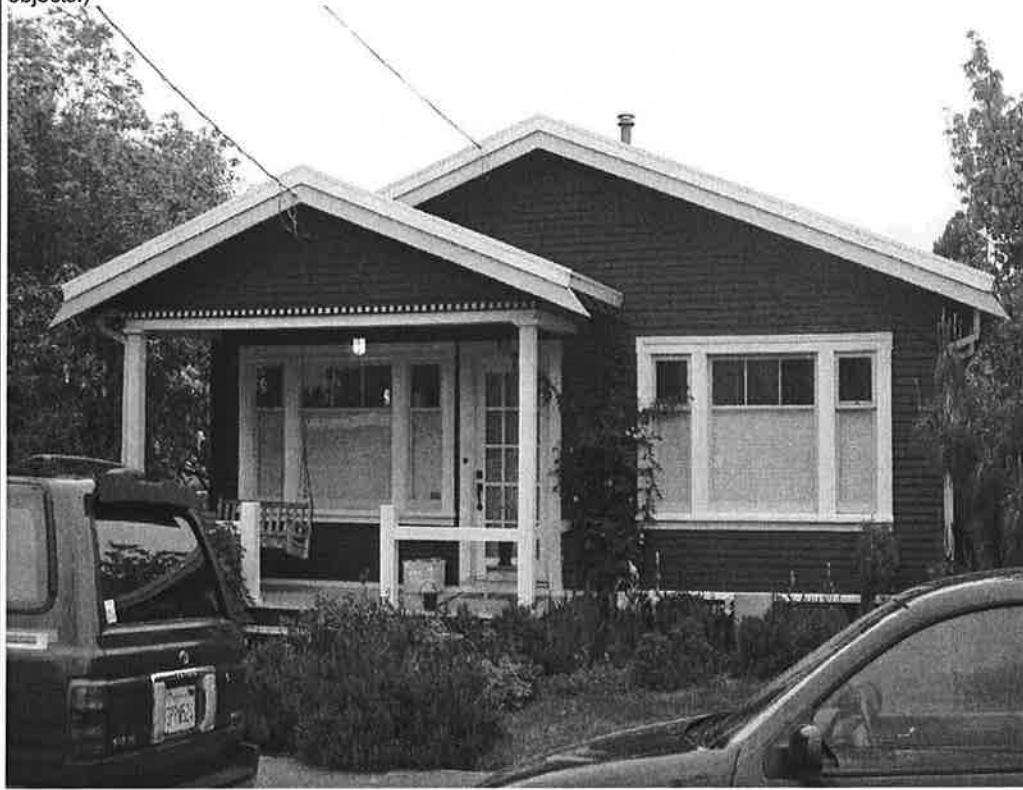
***P3a. Description:** (Describe resource and its major elements. Include design, materials, condition, alterations, size, setting, and boundaries) Historically known as the Anderson-Falor House. This house, built in 1926 is classed as a simple craftsman bungalow. It sits on a post and pier foundation. It has false beveled wooden drop siding painted dark green. The soffit is open with tapered rafter tails and no gutters. Trim colors are yellow and white. The covered front porch is off center to the west with square columns and dentil molding above the header. The 3x5 pane entry door is positioned on the right side of the porch. There is a set of three windows on each side of the entry door. The middle window in each set is a 3 over 1 and is flanked by narrower 1 over 1 windows. The west elevation faces the alleyway that runs from 12th to 13th streets. There is an interior brick chimney that has a metal insert. The west elevation has a small covered porch in the north corner with the rear entry door. A modest grass back yard separates the main house from a single car garage with a small attached apartment of a matching style and scale.

(View, date, accession #)
Front, 3/19/2006
