Bayview Neighborhood Survey

College of the Redwoods

CT 12 Historic Research & Documentation

Spring 2006

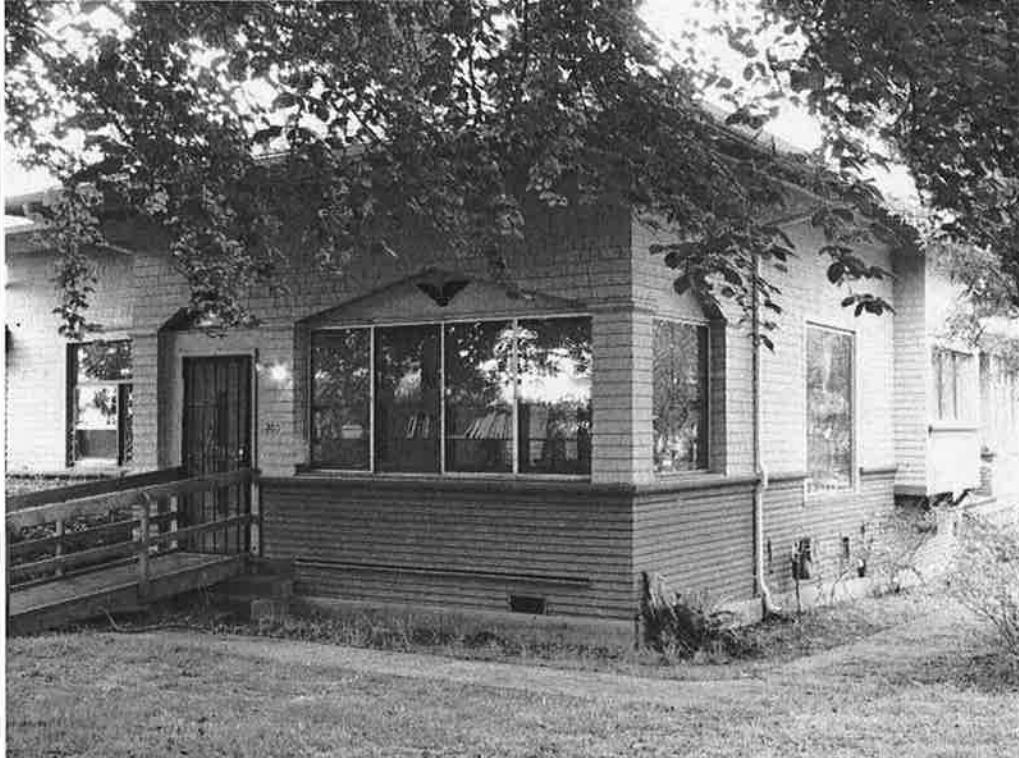
*P3a. Description: (Describe resource and its major elements. Include design, materials, condition, alterations, size, setting, and boundaries) Historically known as the Greenwald House. Built in 1888 and remodeled in 1904. It is now a care home. It has bugalow features with a low roof, shingles above the trim board and horizontal wood siding below the windows. Many of the origional windows have been replaced with aluminum framing except for one double hung window to the left of the front entry. A wheel chair ramps leads to the front door. The front view of the house from 12th street is obscured by vegetation. A 7' tall fence runs along the western property line.

(View, date, accession #)
Front, 3/19/2006

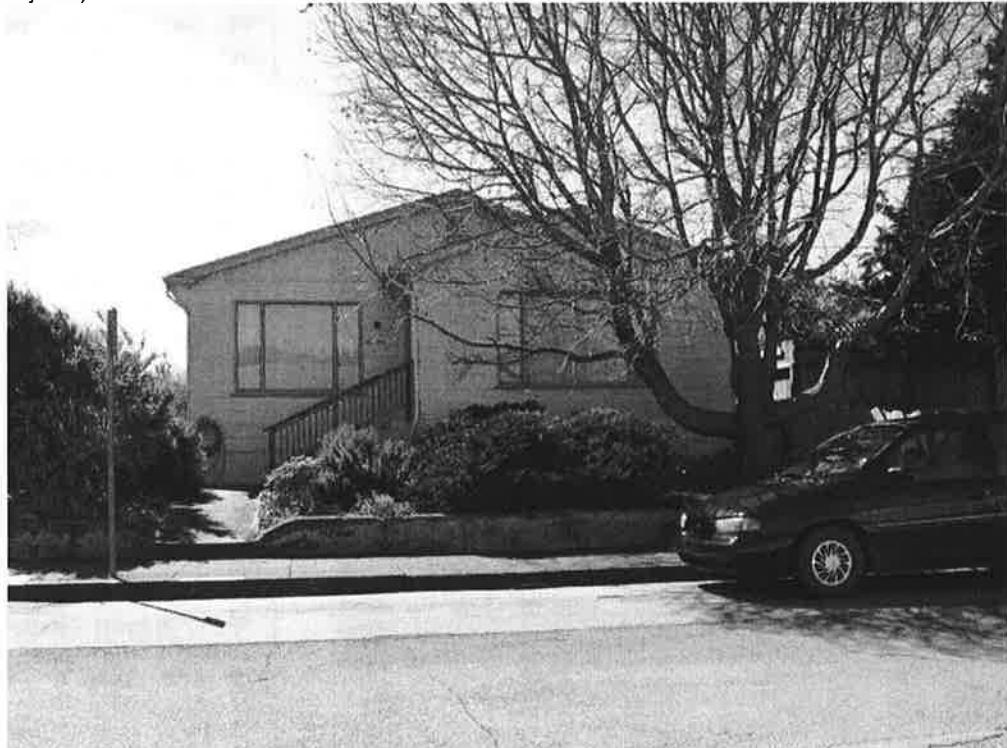
*P3a. Description: (Describe resource and its major elements. Include design, materials, condition, alterations, size, setting, and boundaries) This minimal traditional building was apparently moved in the 1970's to allow room for the HSU Wildlife Center to be built. Today the house is rented to students. It is a single story, with two front facing, layered gables. An alley goes along the east side of the house and allows off street parking and access to a shed roofed out building. The south entrance has a small, mudroom that juts off the main building, while the front entrance on the north elevation is turned so that one enters parallel with the street via a small stair. Eave/cornice returns are the only decorative elements, besides the vertical siding in the upper gables that has a v-notch detail at the bottom. A large maple dominants the north elevation.

P5b. Description of Photo: (View, date, accession #)
Front, 3/19/06

*P6. Date Constructed/Age and Sources: Historic
 Prehistoric Both
moved from site of Wildlife Building on HSU campus

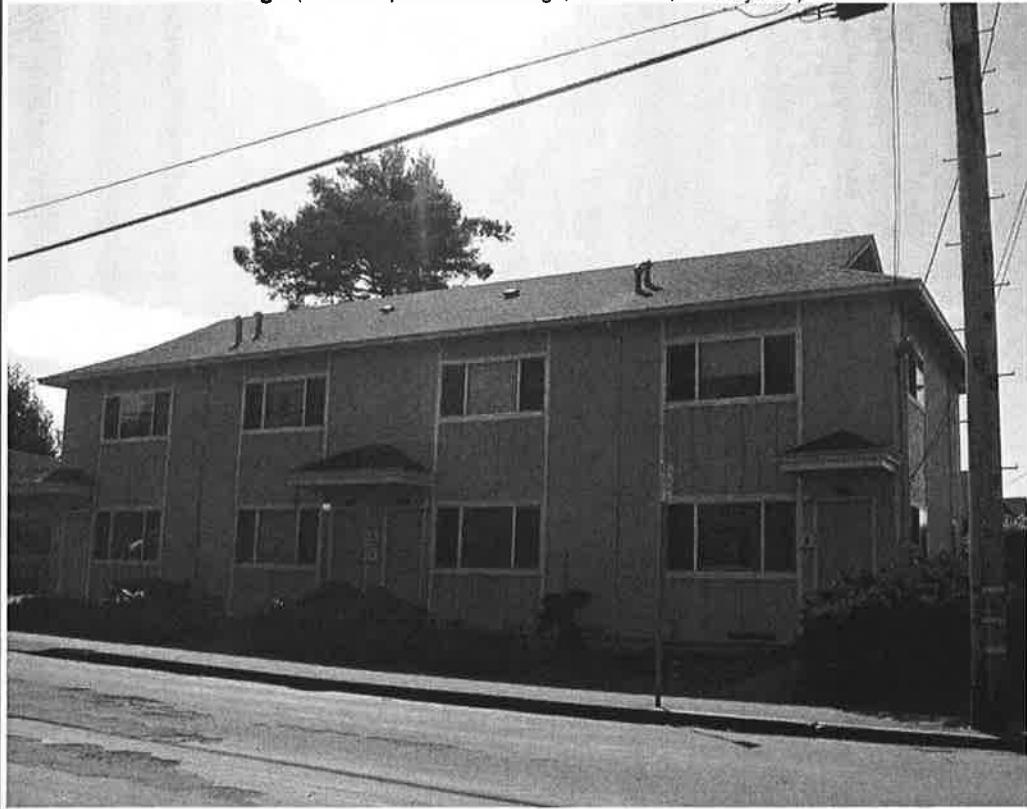
Two story multi-family dwelling. Rectangular, two rooms deep. Dutch hip roof w/composition tile. Small hip roofs over entries. Lacks ornamentation. T1-11 vertical siding.

**P5b. Description of Photo:**(View, date, accession #)
Front, 3/19/2006***P6. Date Constructed/Age and Sources:** Historic
Prehistoric Both***P7. Owner and Address:**
Nordstrom Rentals,
Arcata***P8. Recorded by:** (Name, affiliation, and address)
College of the Redwoods
HPRT CT -12***P9. Date Recorded:**
3/19/2006***P10. Survey Type:** (Describe)
Reconnaissance Survey***P11. Report Citation:** (Cite survey report and other sources, or enter "none.")
Bayview neighborhood, northwest corner***Attachments:** NONE Location Map Sketch Map Continuation Sheet Building, Structure, and Object Record
Archaeological Record District Record Linear Feature Record Milling Station Record Rock Art Record

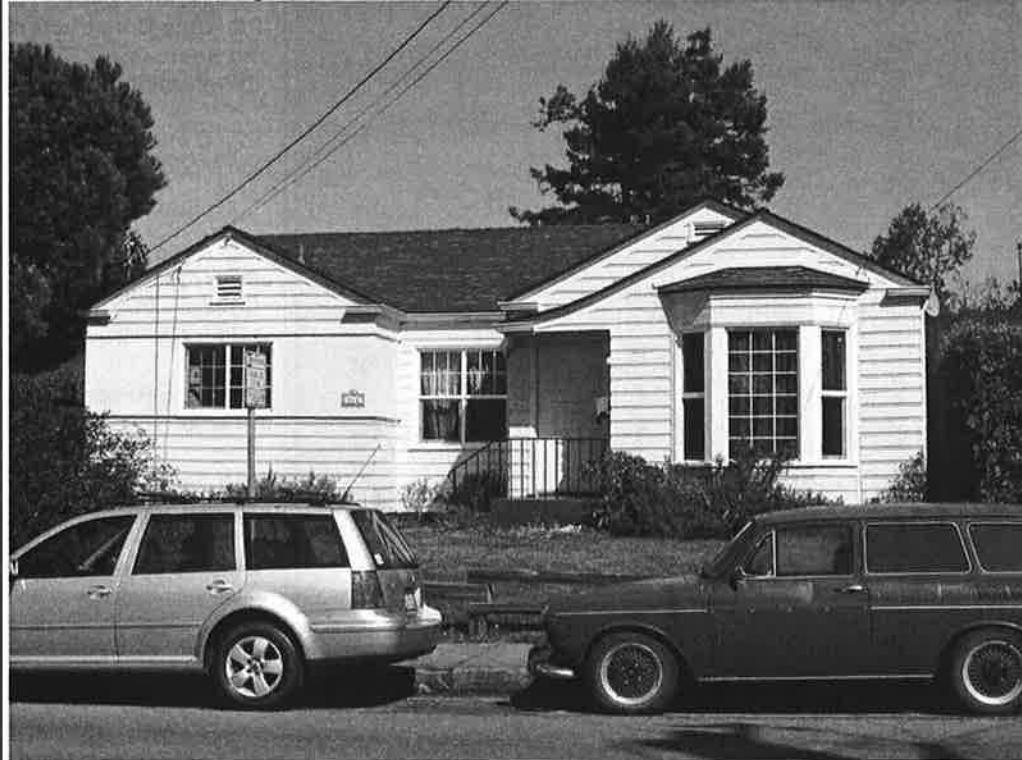
***P3a. Description:** (Describe resource and its major elements. Include design, materials, condition, alterations, size, setting, and boundaries) The front elevation has 3 wide gable ends. Front windows include a slanted bay window with 16 simulated panes at center and two 1 over 1 windows on either side, a vertical slider at the west end with 6 simulated panes in each section and a center window comprised of two 1 over 1's, with 6 simulated panes in each top section. All windows are vinyl. The front door faces the street. A simple iron railing is attached to a concrete stoop. Wide horizontal wood siding covers the entire front surface, from ground to gable tops, except for a section of vertical siding in the center of the west section. All is painted light yellow. The house has enclosed return eaves and composition shingle roofing. The entrance to the two car garage is from the west and accessed by a concrete driveway. The garage doors have been replaced with plywood and a standard door.

**P5b. Description of Photo:**(View, date, accession #)
Front, 3/19/06

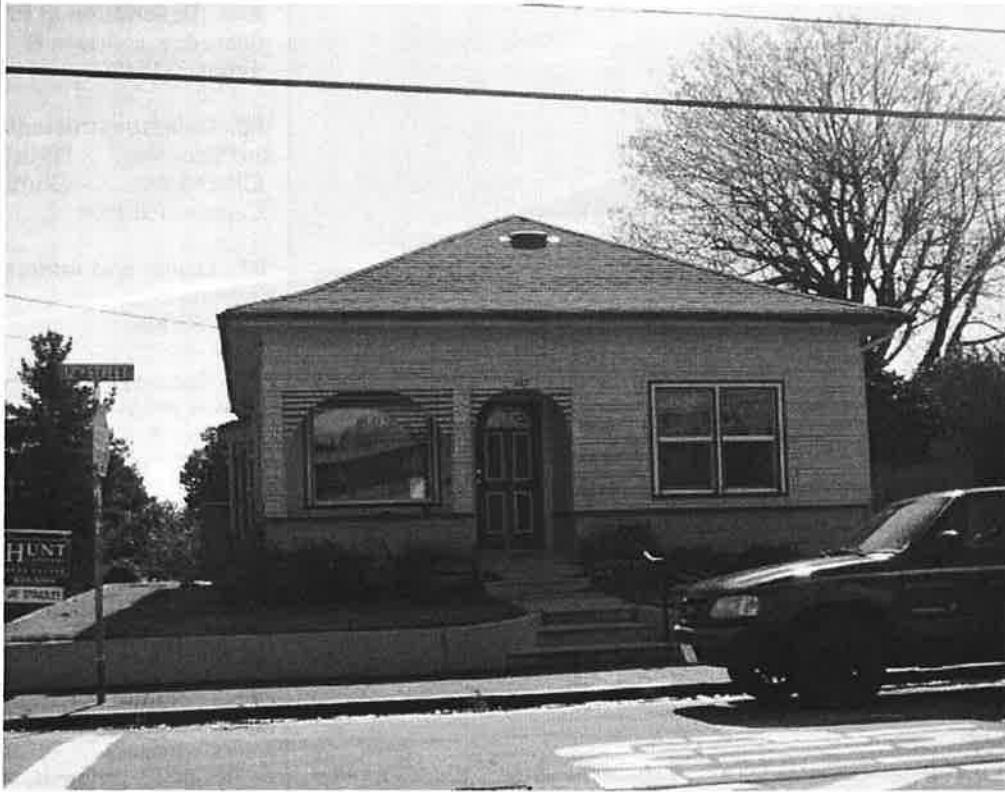
Historically known as the Willie Biasca house. Built in a transitional style with modern elements in 1914. Occupies raised corner lot with concrete retaining wall on east and north elevations. Lower 1/3 of house is wood siding, upper 2/3's is wood shingle painted two hues of beige with white and violet trim. Windows are vinyl 1 over 1. Front door has fanlight window detail. Small raised front porch, with lattice trim at upper front to create an arched shaped opening. Hipped roof, metal gutters, Attached garage, concrete driveway.

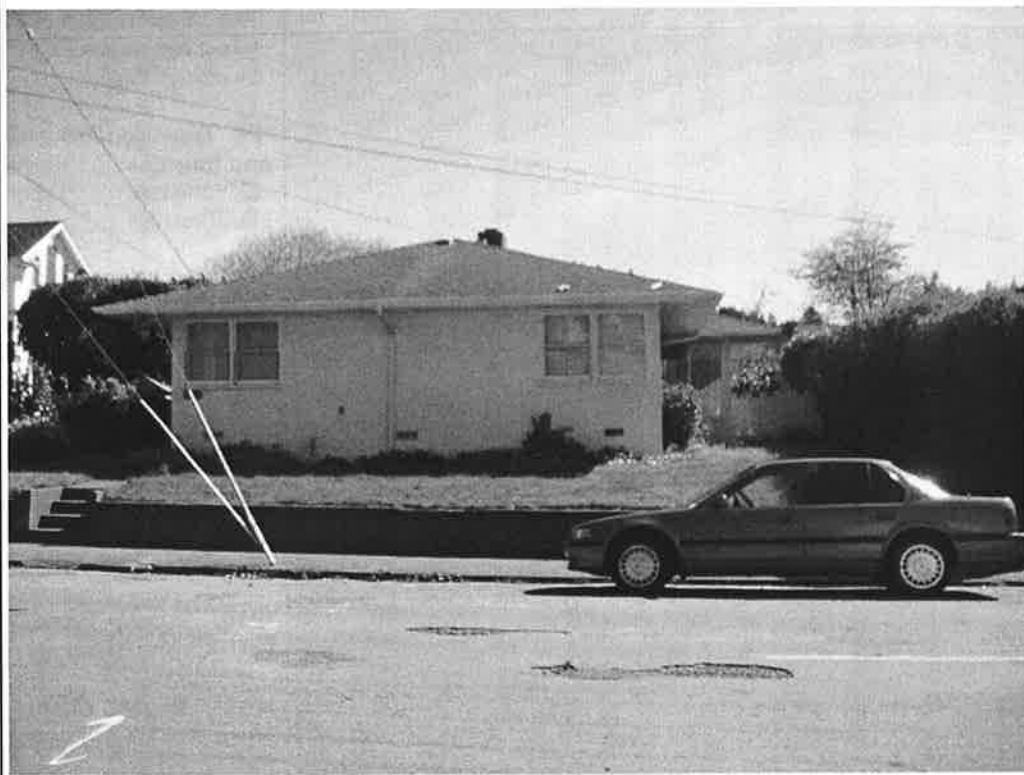
Known as the Leslie Stromborg house. Modern streamlined style, one story. Raised lot with retaining wall on west (front) elevation. Concrete foundation, probable concrete block exterior walls with stucco finish painted light green. White trim. Low sloped hipped roof with composition shingles. Chimney offset from center of roof. Extended eaves on north and south elevations. Metal gutters and downspouts. Street facing elevation has two 1 over 1 windows. South and east elevations have large picture windows. Front door located on North elevation, recessed and away from street. Attached garage faces alley.

**P5b. Description of Photo:**(View, date, accession #)
Front, 3/19/06

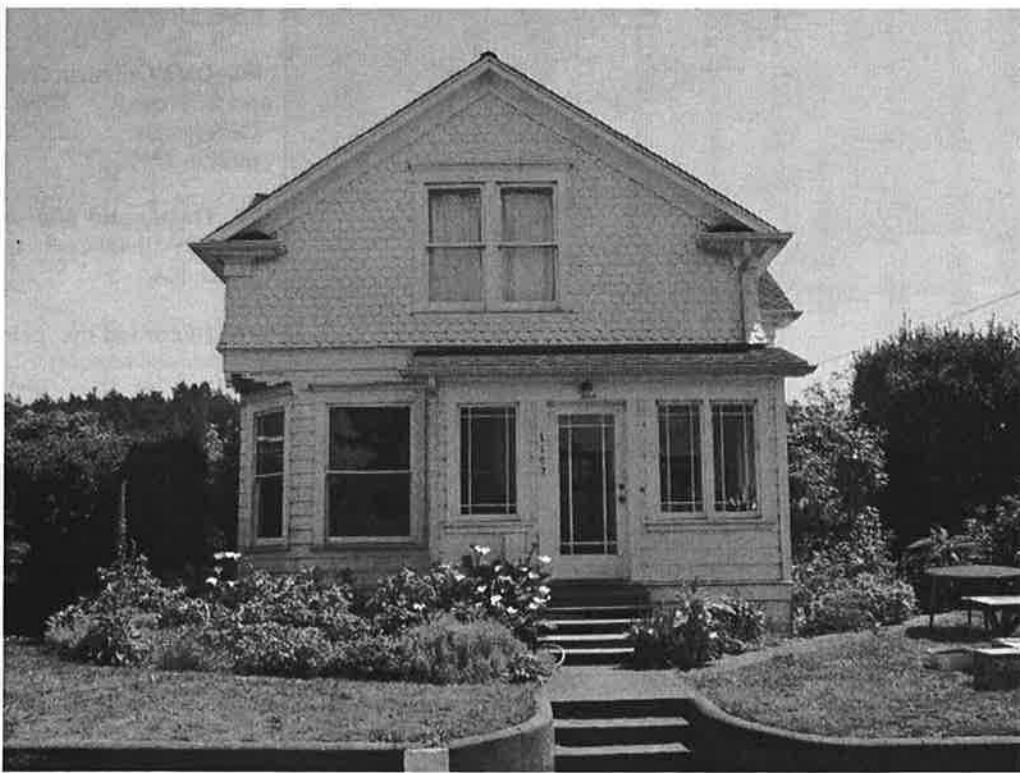
Known as the Inskip House. Victorian with Queen Anne elements, also referred to as transitional or "working man's". Raised lot with concrete retaining wall on west (front) elevation. Post and pier foundation, concrete footers. 1 1/2 stories, wood frame with wood siding below & wood shingles above. Metal gutters and downspouts. Partial reconstruction after 1990's fire. Cross gable roof with return eaves. Enclosed front stoop, original front door is offset towards the south. Slanted bay window at corner of north and west elevations. New roof with added dormer style windows. Other windows are double hung sash 1 over 1. Detached shed with large opening facing outward to alley.
